SERVICE NEWS

VOL. 10, NO. 3, JULY—SEPTEMBER 1983

**RUDDER
THRUST
BEARING
SERVICING**

Controlling Rudder Thrust Bearing Wear

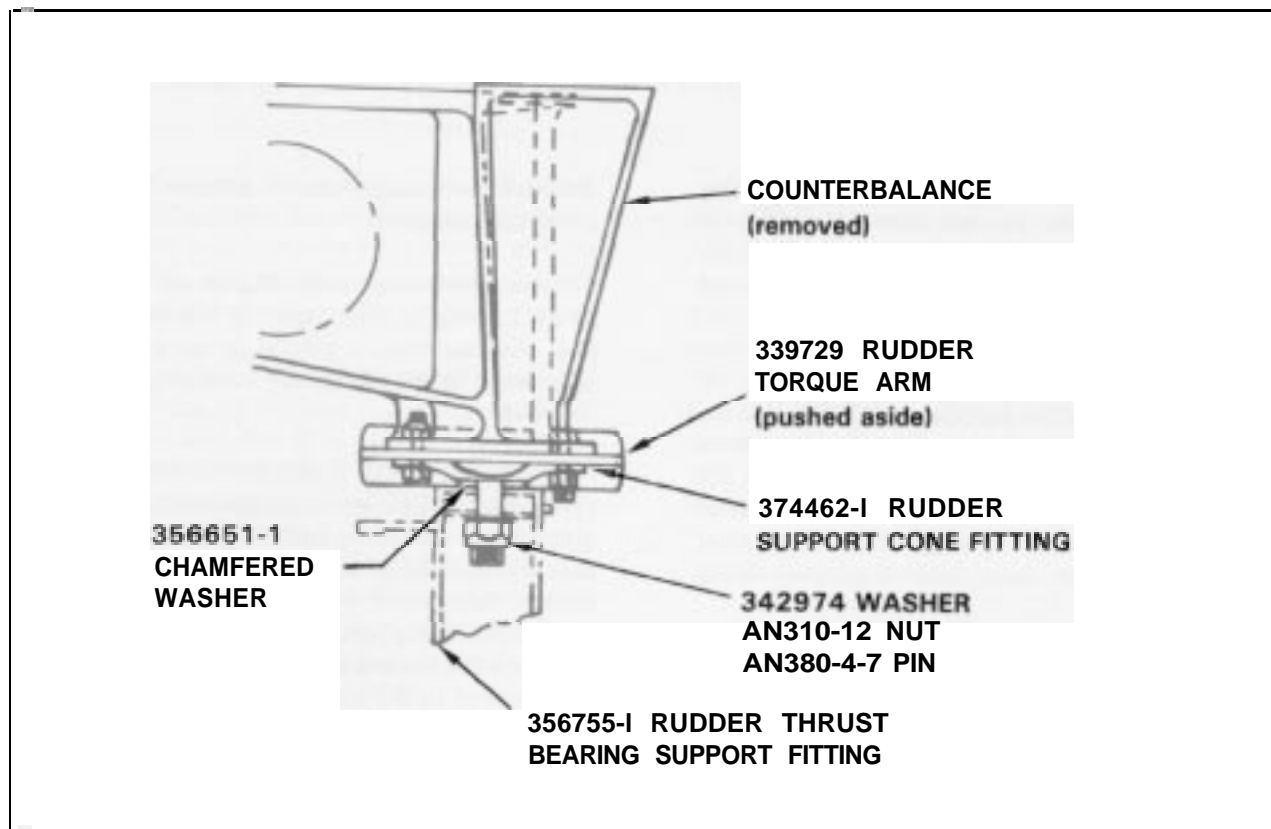
Figure 2. Counterbalance, torque arm, and rudder support cone fitting with associated hardware.

pin, the nut, and the P/N 342974 thrust bearing washer from the rudder support cone fitting (Fig. 2). Examine the nut and washer for signs of damage, corrosion, or wear. If they are sound, they may be saved for reinstallation.

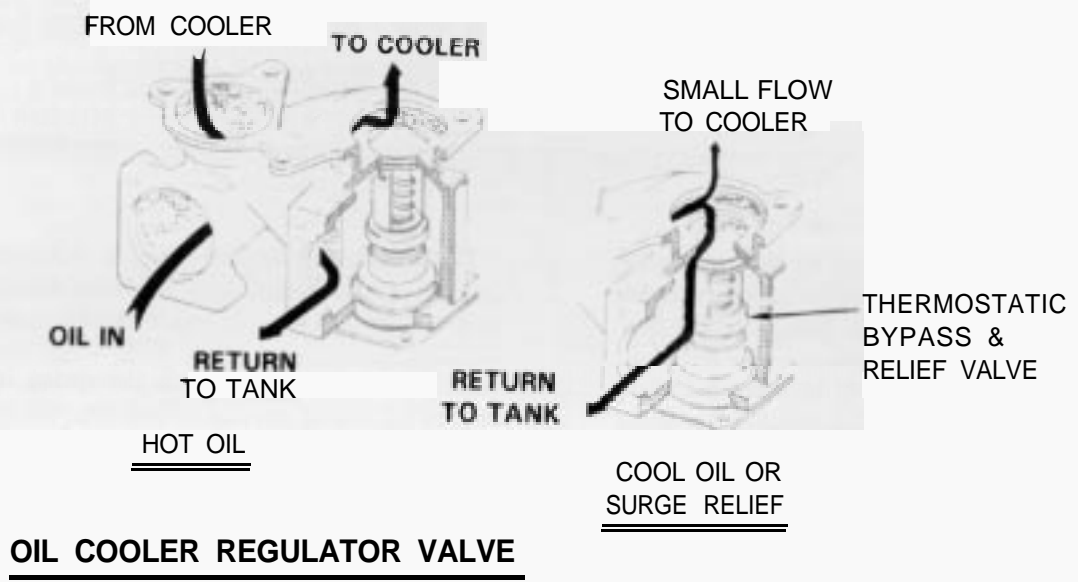
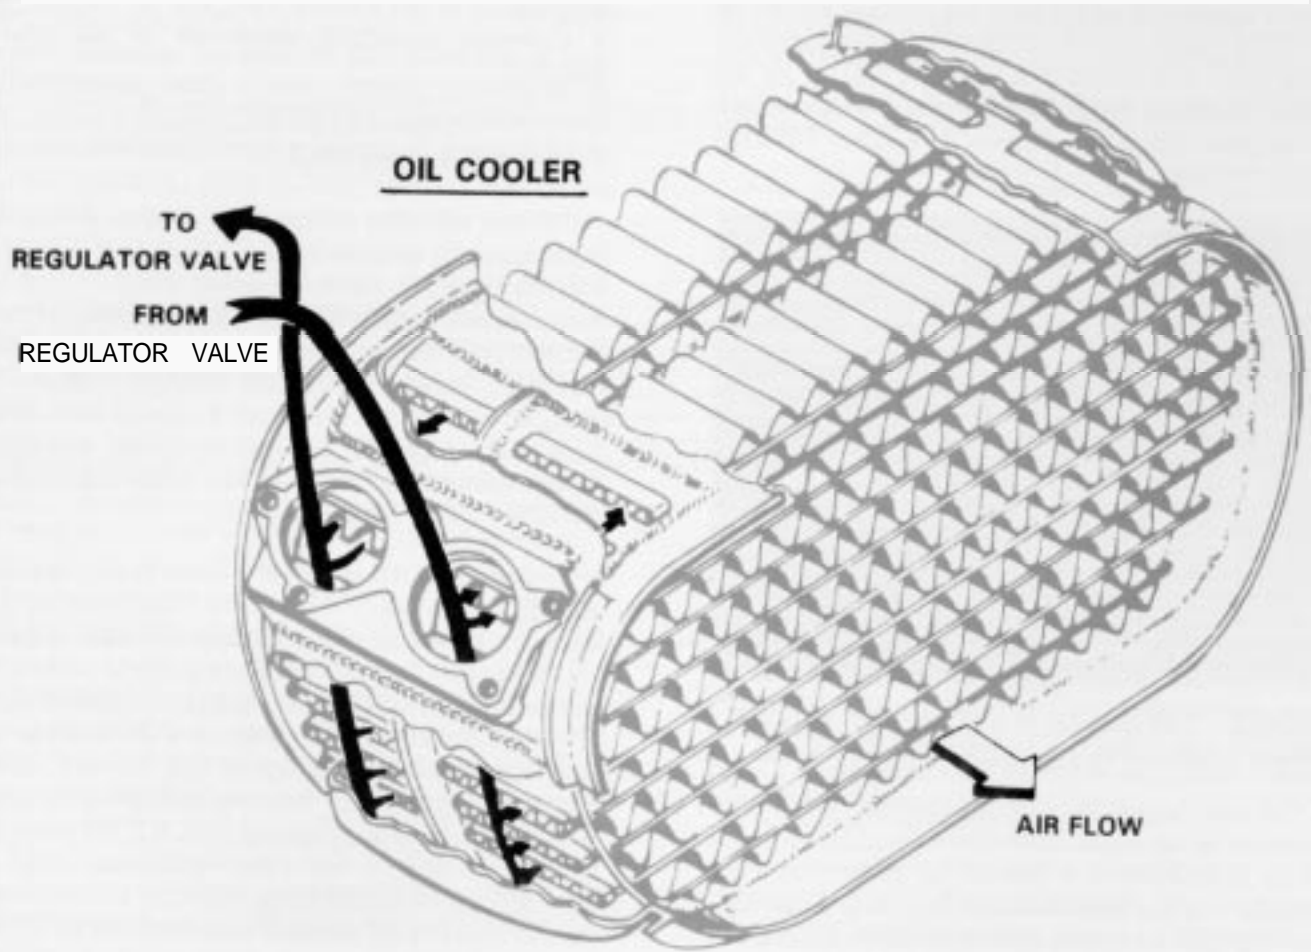
Figure 3. Oil cooler and oil cooler regulator valve detail.

controlled oil cooler flap did not automatically close in this case can be traced to the interaction of the oil temperature control thermostat and the thermostatic bypass and relief valve assembly in the oil cooler regulator valve.

The oil cooler regulator valve directs oil into or bypasses oil around the oil cooler, depending on the temperature of the oil (Figure 3). When the temperature of the oil is less than 54°C (+/-3°), the thermostatic bypass and relief valve is fully open. This allows most of the oil flowing into the oil cooler regulator valve to bypass the oil cooler. At approximately 54°C, the bypass valve starts to close and should be fully closed when the oil temperature reaches approximately 68°C. With the bypass valve fully closed, all the oil entering the regulator valve goes through the oil cooler.

Notice, however, that the 68°C closing temperature of the thermostatic bypass and relief valve is only 1.5°C below the low end of the oil temperature control thermostat closing temperature (69.5°C). With the “fully closed” temperature of the bypass valve so close to the low end of the closing temperature of the oil temperature control thermostat (69.5°C), the bypass valve may not fully close to force all oil through the oil cooler. The bypass valve does not close fully because the oil cooler acts as a heat sink. This heat sink effect allows the thermostatic bypass and relief valve to respond as though the oil temperature were cooler than it actually is. Since the bypass valve is not fully closed, oil that is hotter than the closing temperature of the bypass valve reaches the oil temperature control thermostat. As long as the temperature of the oil reaching the oil temperature control thermostat is greater than 69.5°C, the cooler flap will remain **open**. This keeps full air flow moving through the oil cooler, which further aggravates the heat sink effect.

Lockheed engineering’s recommendation is therefore the following: if a solid-state thermostat-controlled oil cooler flap does not automatically close after takeoff, place the oil cooler flap switch to **CLOSE** until the flap reaches 40% and then put the switch back to **AUTOMATIC**. The **oil** cooler flap will continue to close until it reaches approximately 5%; the oil temperature should stabilize at approximately 76°C.

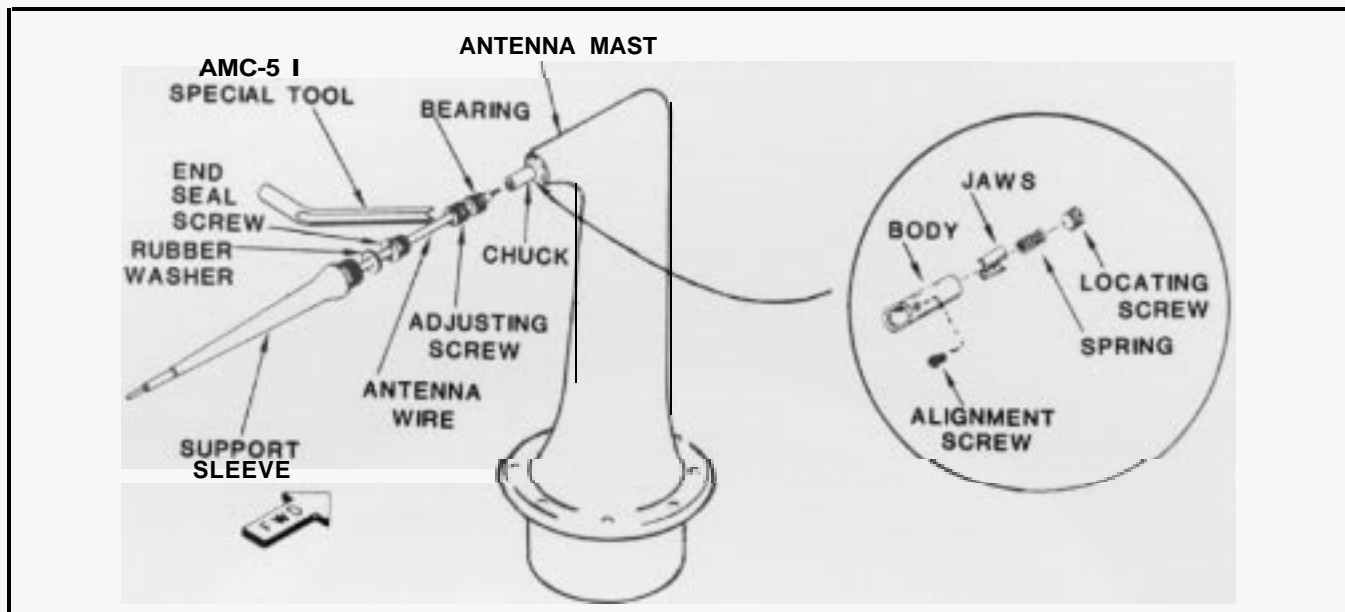
Figure 2 AMVL-6f antenna mast assembly and chuck assembly detail

The most common cause of wire failure has been shown to be corrosion. Laboratory examination of the chuck assemblies in a number of cases where the antenna wire had failed indicated that the principal corrosion product was iron oxide (rust) from the copper-coated steel antenna wire and copper-coated steel chuck spring. The stainless steel chuck assembly body and spring locating screw and the brass chuck jaws are apparently not corroding. An exploded view of the wire chuck assembly and its installation is shown in Figure 2.

Evidently, the problem begins when the copper coating of the antenna wire is broken during preparation for installation. If the wire is nicked at all, it exposes the steel core of the wire, which subsequently rusts. The copper coating on the spring is probably rubbed off during normal service use, which causes the exposed steel to rust when moisture enters the antenna mast.

Slide all of the antenna mast attaching parts (except the chuck) onto the antenna wire, as illustrated in Figure 2. They go on in this order: antenna support sleeve, rubber washer, end seal screw, and the adjusting screw. These parts should be pushed back on the wire approximately 12 inches before attaching the antenna. Slip the antenna wire bearing over the conductor and insert the full length of the bare wire conductor into the chuck assembly. Three or four sharp in-and-out motions should be made to ensure proper gripping of the conductor by the chuck jaws.

After assembly, carefully remove the locating screw on the end of the chuck assembly and fill it with corrosion preventive compound. Also, sparingly apply corrosion preventive compound to the outside junction point between the chuck jaws and antenna wire. Remove any compound that may get on the exterior of the chuck assembly so that the wire will bond electrically in the fitting when installation in the mast is complete.
