SERVICE NEWS

Vol. 1, No. 3, July- September 1974

Troubleshooting the Hercules Fuel Quantity

INDICATING SYSTEM

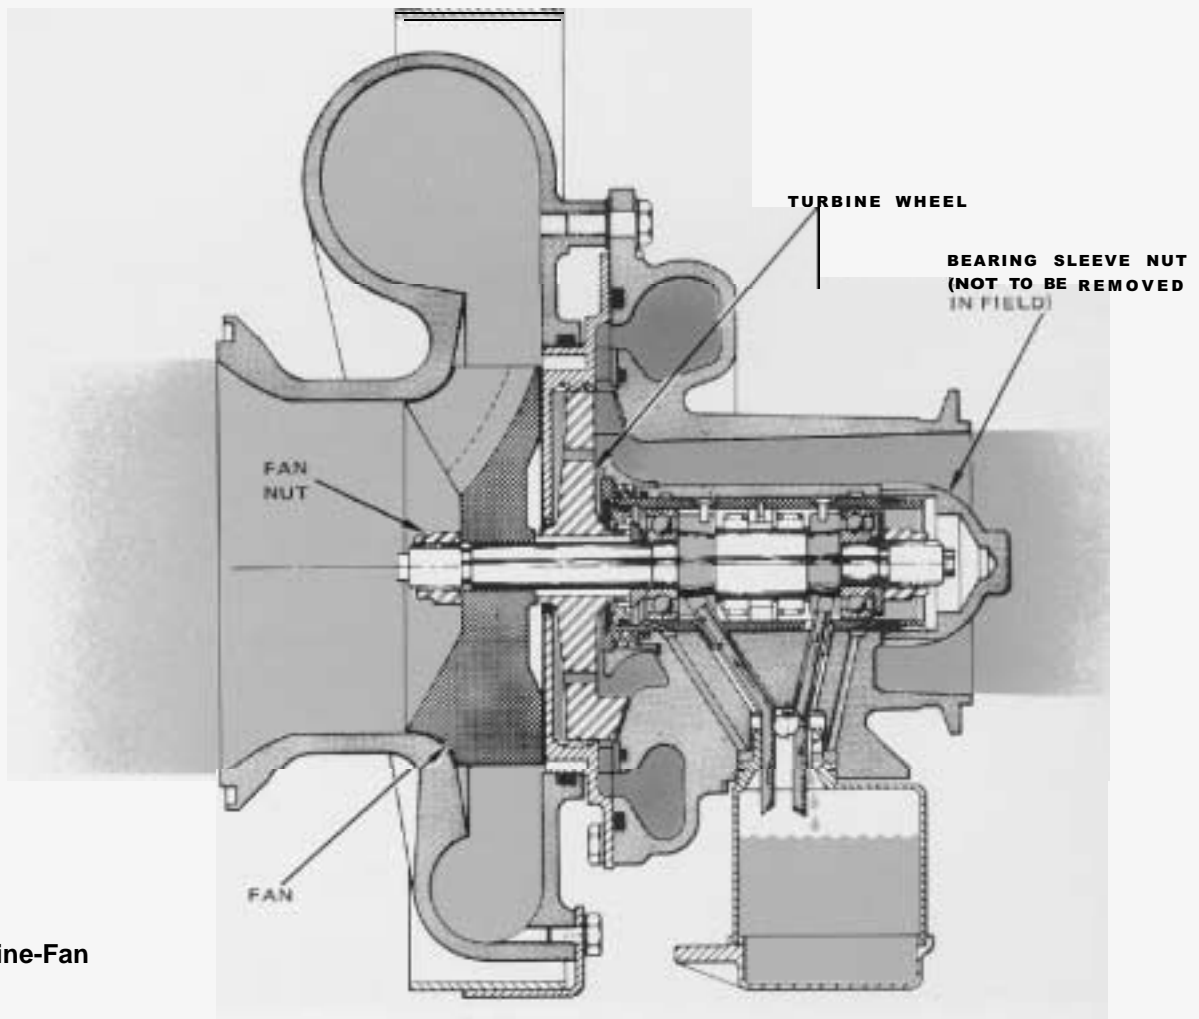
**Cutaway of
JetStar Turbine-Fan
Assembly**

We wish to elaborate on the approach to the problem of a "frozen" turbine wheel. Lockheed has also heard field reports that indicate attempts were made to unstick turbine rotors by pushing on the fan blades. Damage to these elements, although not apparent, can be destructive at operating speeds near 60,000 RPM. If the rotor sticks on a high time refrigeration turbine, the unit should be replaced.

On rare occasions, it has happened that, during the "wear in" period of earlier model refrigeration units, the rim of the turbine wheel stuck in the cadmium seal in the nozzle plate. Rubbing here may occur for as long as 500 hours of operation before the wheel "seats in" to the seal. If attempts to start the refrigeration unit fail with the engines at full RPM, and there is reason to believe that non-rotation is due to seal drag, you can try a method of applying mechanical torque that has been approved.
