SERVICE NEWS

MAIN LANDING GEAR RUB

Vol. 13, No. 1, January - March 1986

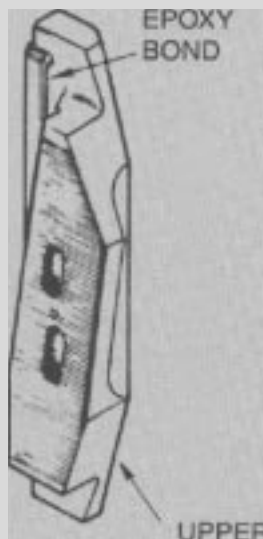
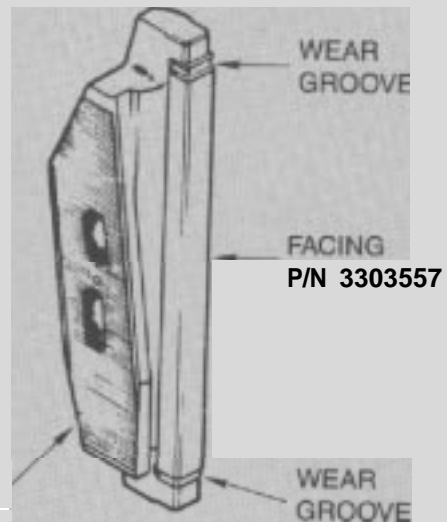
Figure 2. Upper track shoe assemblies.

2) for excessive wear according to the instructions in the appropriate maintenance manual, and replace if necessary.

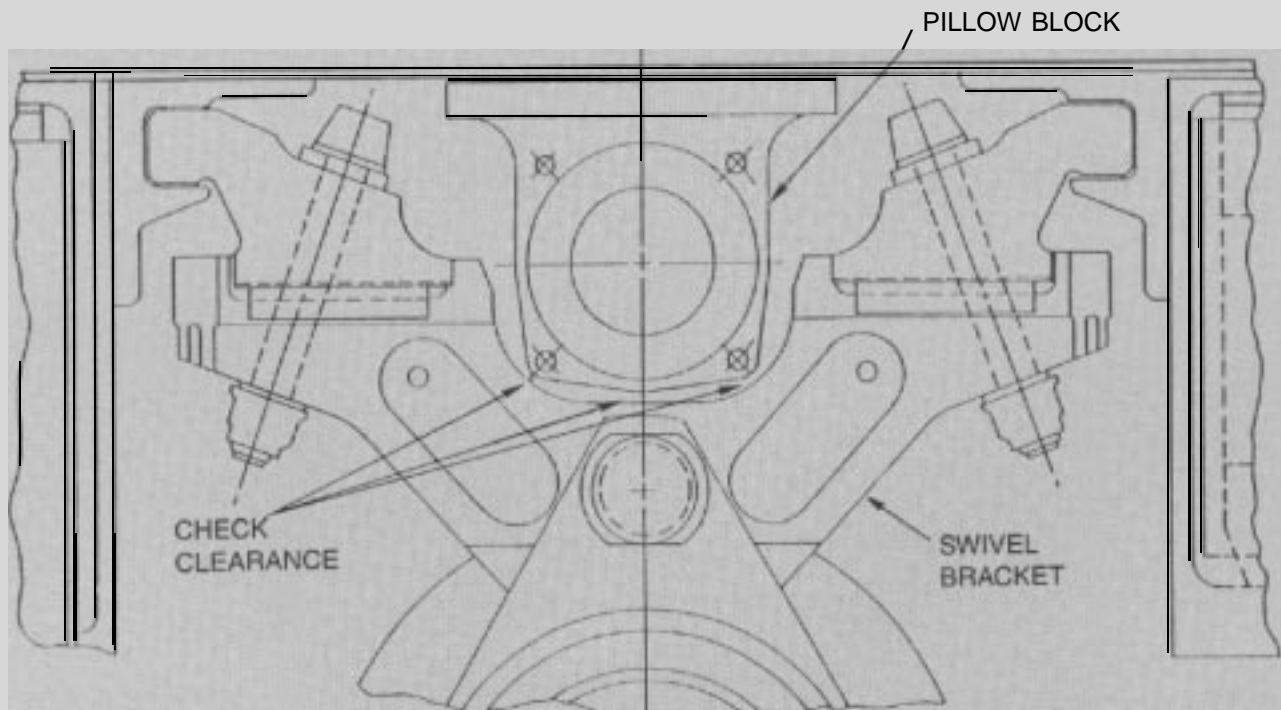
Figure 4. Clearance check between swivel bracket and pillow block.

When thin serrated plates are substituted, care must be taken to ensure that there is adequate **clearance** between the swivel bracket and the ball screw pillow block (see Figure 4). It will be necessary to verify that this clearance exists during functional extension and retraction operations on the ground. The clearance should be no less than 0.015 inch. If the clearance is less than this, the laminated shims (P/N 373556-1) between the pillow block and the side panel may be reduced in thickness until the required clearance is obtained (see Figure 5). If there is only a single point of contact, an additional option may be considered for obtaining the required clearance. That option is to remove up to 0.020 inch of the pillow block edge material at the point where the interference is taking place.

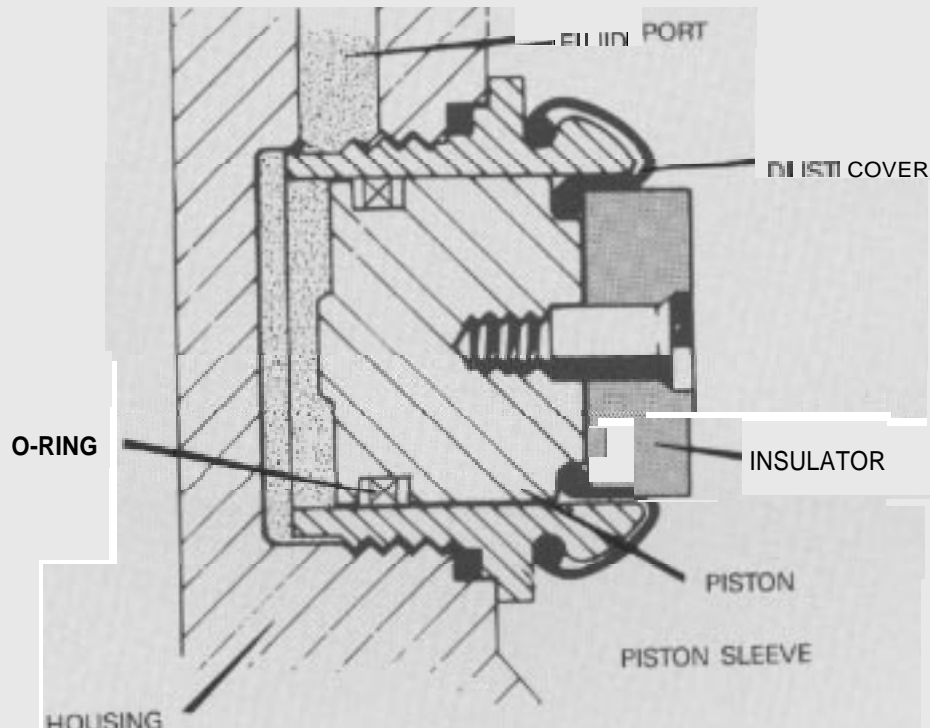
MULTI-DISC ASSEMBLY

There have been a number of reports of Goodyear multi-disc brakes being removed because of crushed or broken insulators. Here is a little background information on the problem, and some guidelines for inspection and acceptance or rejection of brake piston insulators.

Originally there was no specific requirement for compression strength or load testing of brake piston insulators. After the problem of broken and crushed insulators was reported, the parts were tested by Raymark and Abex, the two vendors concerned. The tests revealed that the Raymark parts crushed at 9,000-13,000 pounds, while the Abex parts failed at 20,000-25,000 pounds.

For inspection of used insulators, parts that are of inadequate strength usually delaminate and are therefore easy to identify. Any insulator that is starting to delaminate should be replaced. Also check visually for blisters, nicks, and cracks. Surface cracks are acceptable; but cracks that extend into the screw hole are cause for rejection. The height of the insulator is also important in determining if a part may be reinstalled for another run. Brake piston insulators less than 0.669 inches high should not be continued in service.
