SERVICE NEWS

C-130 Ramp Hook Retainers

Vol. 20, No. 4, October-December 1993

C-130 RAMP HOOK RETAINER MISLOCATION

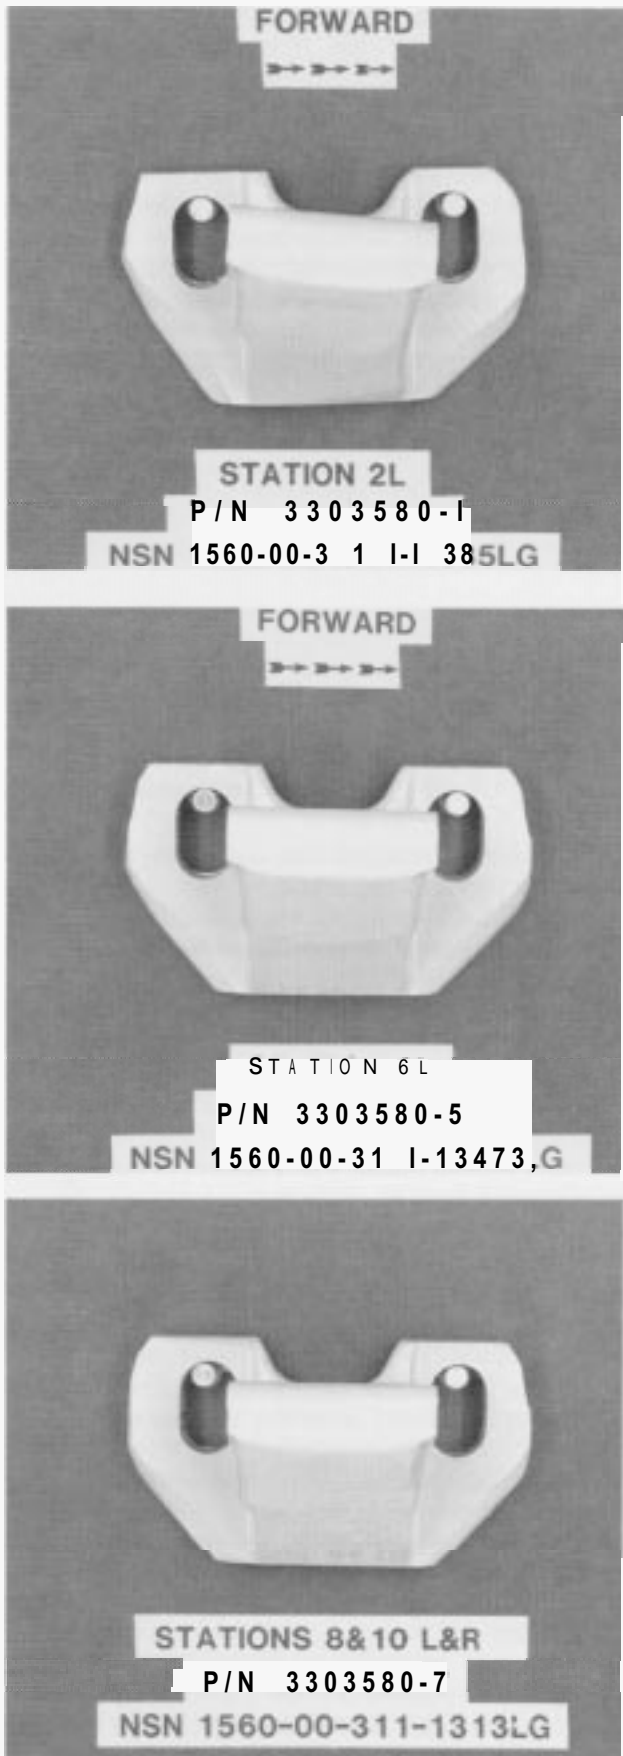
Ramp hook retainers that are not located in their intended positions but randomly intermingled can become hidden obstructions to successful ramp rigging. The reason “hidden” is the operative word here is that it is virtually impossible to identify any of the hook retainers simply by looking at them, or connect the appearance of a retainer with its intended location on the longeron. Put another way, all of the ramp hook retainers look pretty much alike, and even experienced technicians will be hard-pressed to distinguish one from the other without finding a part number or making some careful measurements (Figure 4).

Figure 4. Locking lug angles range from small to zero. “Eyeball” identification is next to impossible.

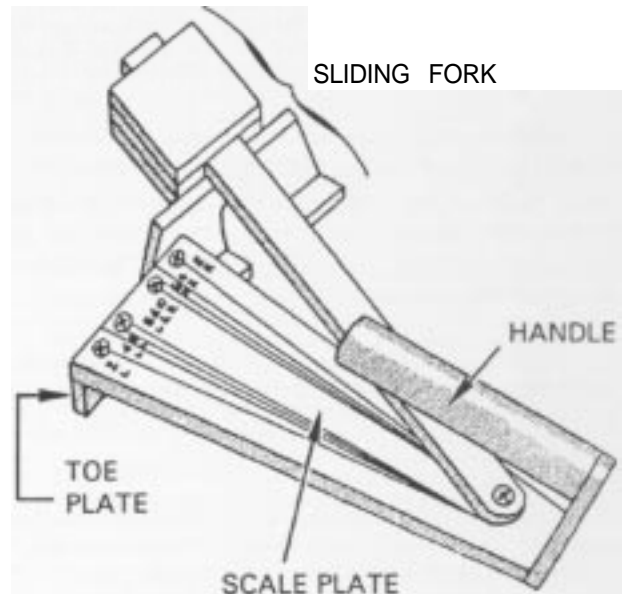
Figure 7. The design of the identification tool's scale plate makes it easy to distinguish between R and L retainers.

The actual angles being measured are shown in Figure 1. Note that although the same angles are shown for corresponding positions on each side of the aircraft, the retainer locking lugs on the left and right sides are angled in the opposite directions. The use of the tool makes it easy to distinguish between right and left retainers since the R and L indications are displayed on opposite sides of the scale plate centerline.

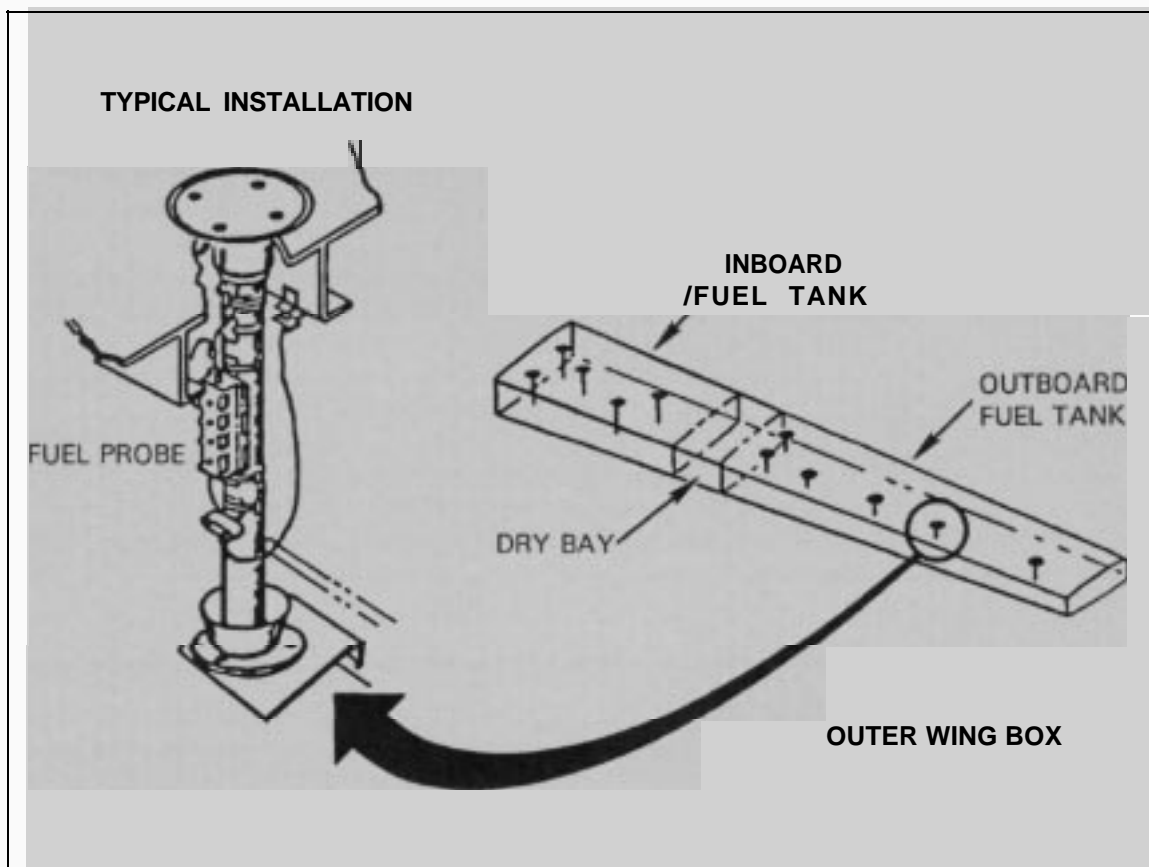
Lockheed's approach to reducing the necessity for human beings to enter integral fuel tanks is twofold; namely, to improve the integrity of the fuel sealing processes during production, and to mount the fuel quantity probes externally on the upper surface of the wing. Externally-mounted probes can be replaced and serviced from outside the tank (see Figure 1).

Figure 1. Mounting fuel quantity probes externally reduces the need for personnel to enter the tanks, reducing both downtime and maintenance costs.

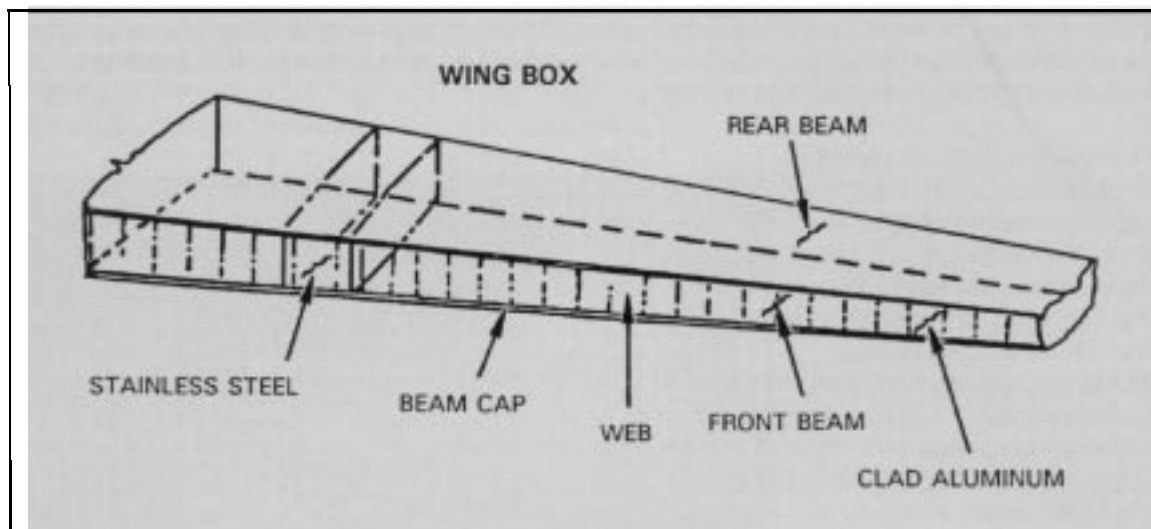
Wash rack personnel generally agree that few areas on the airplane are harder to clean than the soot-covered surfaces of the wing beams. Soot tends to embed in the paint, often making removal of this carbon residue laborious and difficult. If not removed, however, the carbon will, in time, penetrate the protective coating on the webs and establish a galvanic cell with the high-strength aluminum alloy. The result is pitting and exfoliation corrosion.

Figure 3. Using clad 7075-T6 aluminum on the wing beam webs helps provide increased corrosion resistance.

To afford an extra measure of protection to the wing beam webs, Lockheed now uses clad 7075-T6 aluminum alloy sheet for webs instead of nonclad sheet (Figure 3). Cladding is recognized as paramount protection for high-strength aluminum alloys because of its sacrificial nature. This change from nonclad to clad went into effect at LAC 4827.

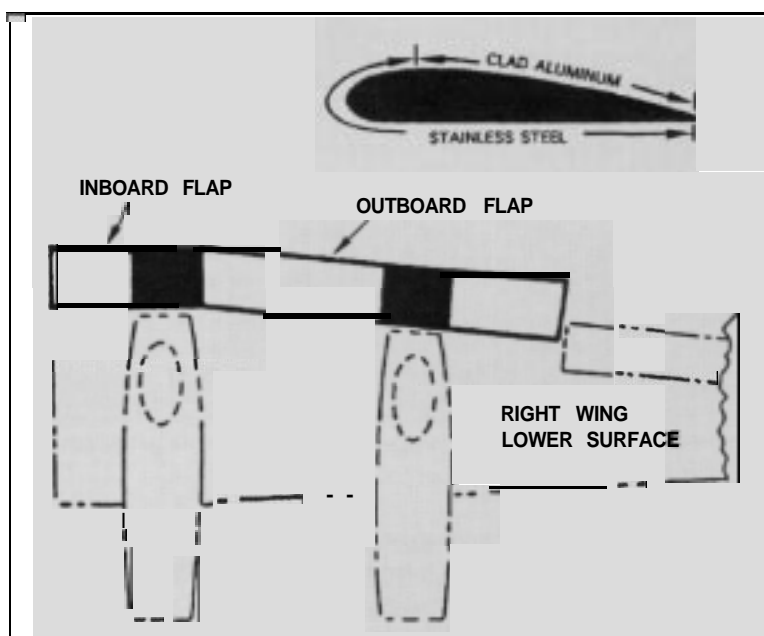
Stainless steel sheet of 301 alloy proved successful in both resisting corrosion and fatigue cracking during the service evaluations. It proved better than either titanium or aluminum alloy 2219-T81. Effective on Lockheed aircraft serial number LAC 5091 and up, the affected skins are 0.025-inch stainless steel (Figure 4).

Figure 4. Wing flap skins of stainless steel sheet of 301 alloy are more resistant to fatigue cracking and corrosion than either aluminum or titanium.
