# ***SERVICE NEWS***

A SERVICE PUBLICATION OF  
LOCKHEED AERONAUTICAL  
SYSTEMS COMPANY

Vol 21, No.3, July-September 1994

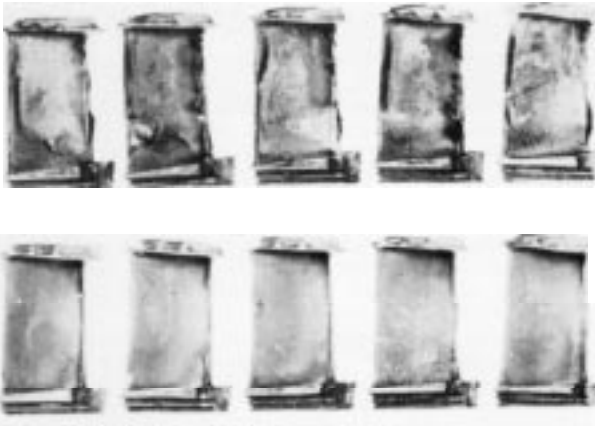
Turbine blades and vanes are subject to gradual deterioration as engine operating hours accumulate. The process is commonly referred to as sulfidation. Turbine sulfidation is caused by the accelerated oxidation of metals in the presence of sulfur ions, in particular sulfides and sulfates. The oxidized metal goes out the tailpipe, leaving eroded blade and vane surfaces behind.

**First stage turbine blades after a service test.**  
**Top row: uncoated alloy.**  
**Bottom row: the same alloy protected with Alpak.**

To help prevent such damage to the metal surfaces and extend the service life of the turbine section components most often affected by sulfidation, diffused coatings of aluminum or aluminum and chromium (often referred to as Alpak and AEP, respectively) are applied to new turbine blade and vane surfaces.

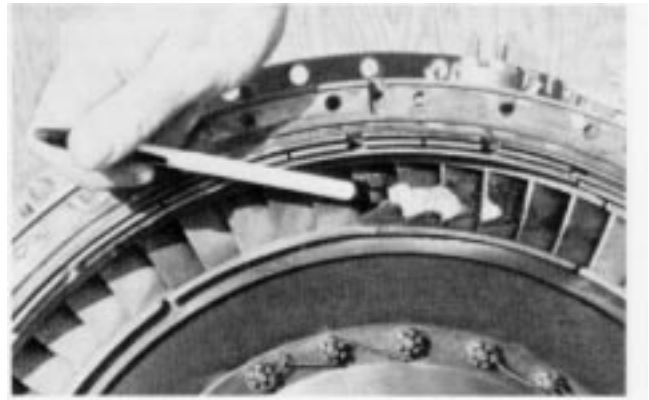
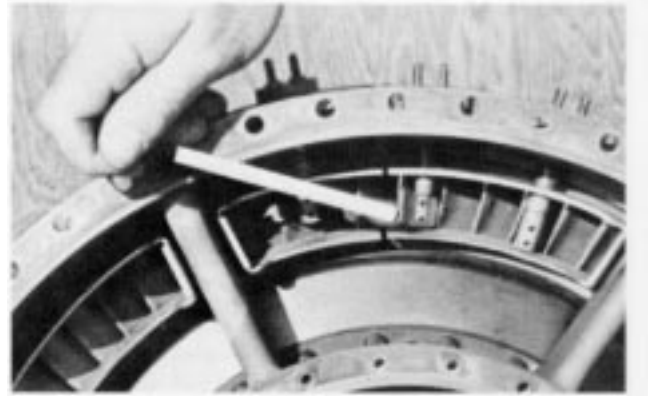
**This turbine wane burn-through was caused by the use of thermocouples of the incorrect type.**

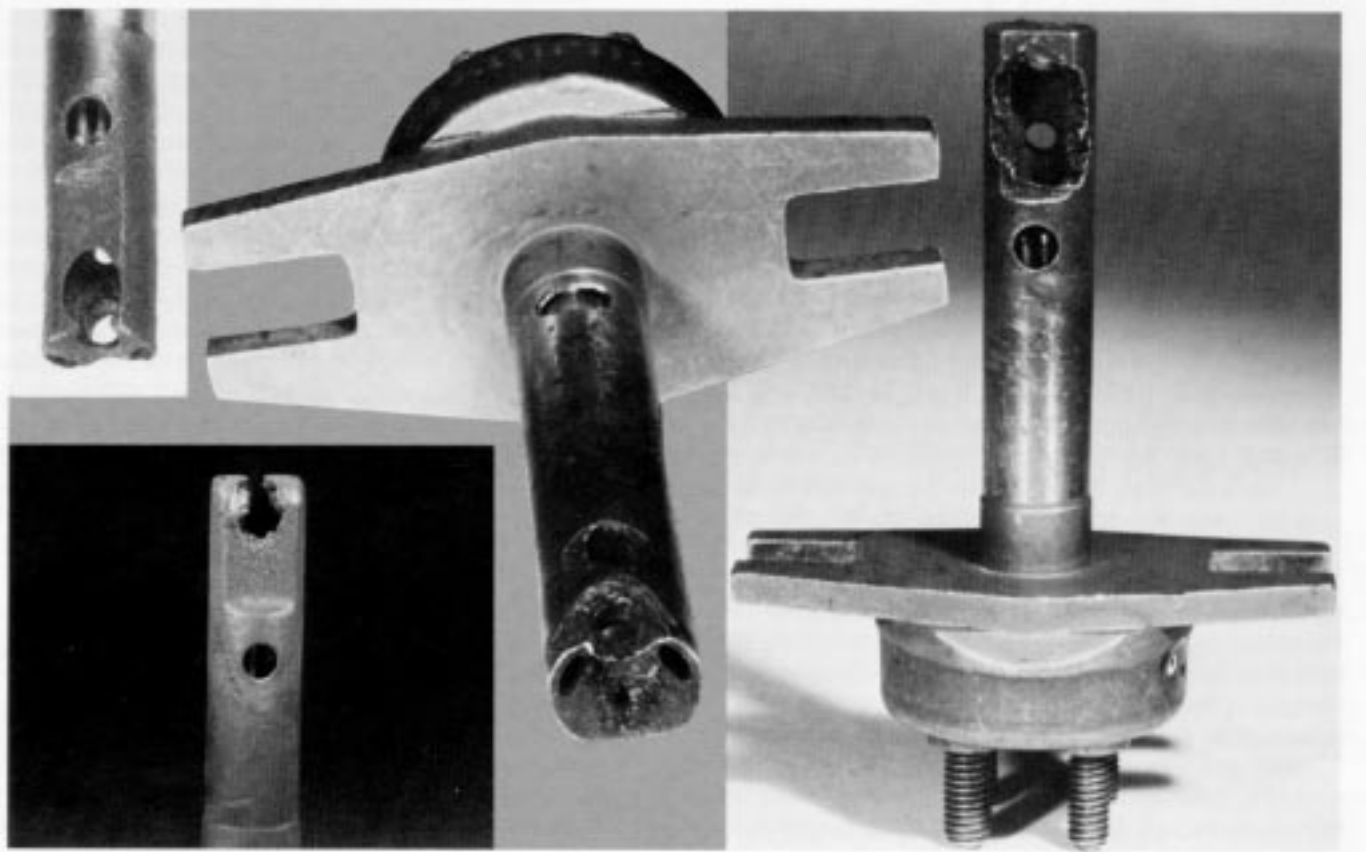
An important consequence of this effect is that over time, thermocouple problems tend to be progressive and cumulative. A single thermocouple failure can begin a snowballing chain of events in which the increased fuel flow-and resulting higher temperatures-cause a second thermocouple to fail, and then another, and so on until the engine is severely overheating.

Eroded or defective thermocouples that are still producing current can also cause temperature control errors, although for a different reason. In fact, the temperature error in these cases can be even more severe than when a thermocouple has dropped completely off line. One thermocouple with the aft wall of the probe tip eroded, for example, can cause the true operating TIT to increase by as much as 7.5°C.

**All of these thermocouples were damaged by exposure to overtemperature conditions.**

One of the most important things to remember about thermocouple inspections is to do it often enough. Finding more than three defective thermocouples in one engine at inspection time is a good indication that the period between inspections needs to be shortened.

When thermocouples are removed for examination, be sure to tag them as they are removed and keep a record of the positions where they were located. The condition of individual thermocouples often provides valuable clues about underlying problems involving other components. For example, thermocouples with badly burned probe tips or unusual carbon deposits suggest malfunctioning fuel nozzles or defective combustion liners, as does repeated thermocouple failures at the same location.
