SERVICE NEWS

TROUBLESHOOTING HERCULES
AIR CONDITIONING

Vol. 16, No. 2, April-June 1989

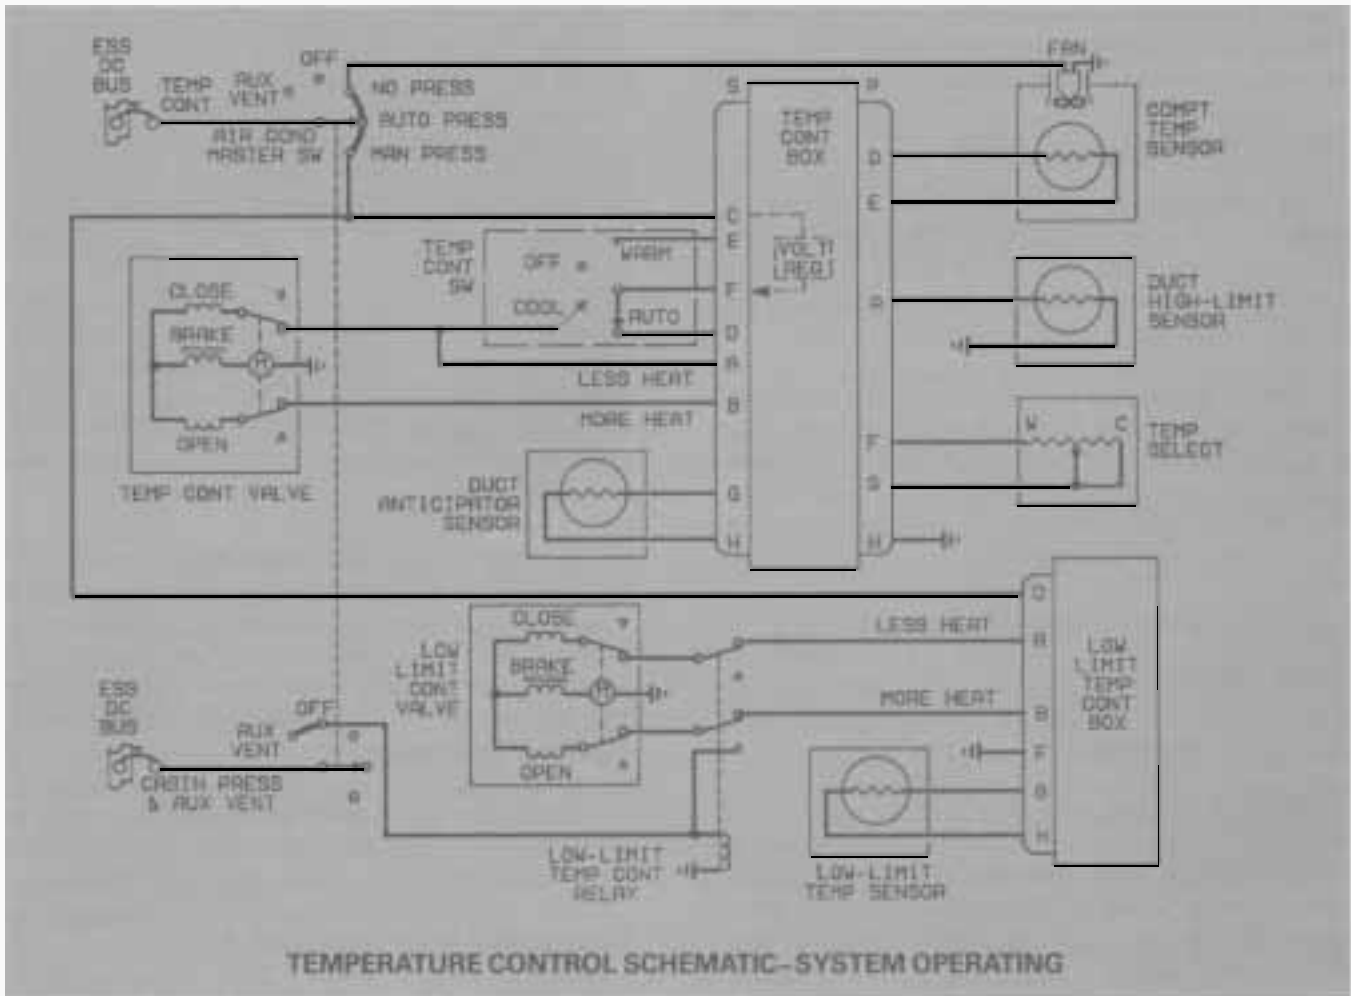
Figure 2

Compartment temperature control is accomplished by allowing bleed air to bypass the refrigeration unit and mix with the cool air from the water separator. The hot air is added into the conditioned air supply duct downstream from the water separator. The amount of hot air bypassed is

regulated by the temperature control valve. Both manual and automatic controls are provided for operation of the valve.

- The **temperature selector rheostat** serves as the system's basic control. It establishes the temperature level which the system must maintain. The selectors for both flight station and cargo compartment systems are located on the overhead air conditioning control panel in the flight station.
- The **compartment temperature sensor** functions as the primary sensing unit for temperature control. It provides actual compartment temperature information to the control box. The cargo compartment unit is located on the

- The **duct anticipator sensor** is sensitive to temperature change. It helps to control the driving time of the temperature control valve to prevent overshooting. The anticipator sensor is installed in the conditioned air supply duct downstream from where the cool air from the water separator and hot bypass air are mixed.
- The **duct high-limit sensor** is a safety control. It limits the temperature so that the ducts will not be subjected to excessive heat. The high-limit sensor is installed in the conditioned air supply duct downstream of the anticipator sensor.

As the temperature control valve drives in response to a demand for an increase or decrease in heating or cooling, the duct temperature begins to change. This change is detected by the duct anticipator, which causes a signal to be developed in the control box opposing the temperature difference error signal.

The result is to inhibit the valve driving signal. As duct temperature stabilizes, the anticipator circuit is satisfied and the temperature change signal is removed. If the compartment temperature has not reached the desired level by then, an error condition still exists and the temperature control valve will begin to drive again.

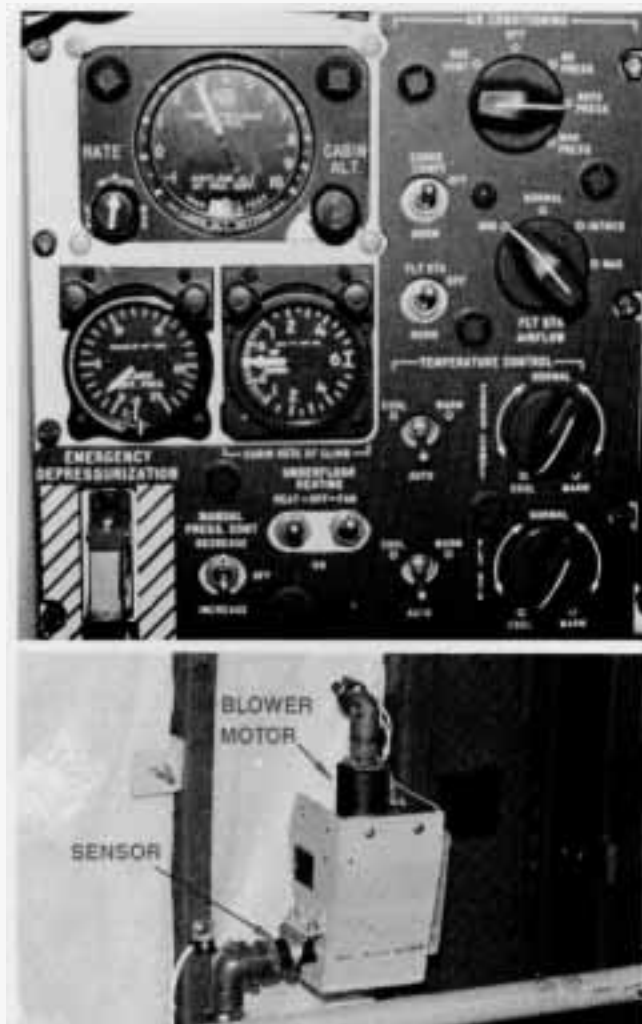
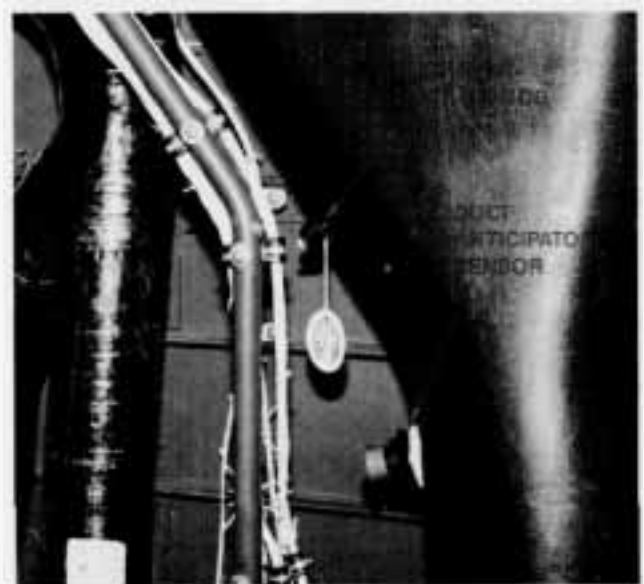
Left: Air conditioning controls, flight station overhead control panel. Left, below: Cargo compartment temperature sensor. Below: Underwing area, right side.

Aft side of FS 245 bulkhead, on right.

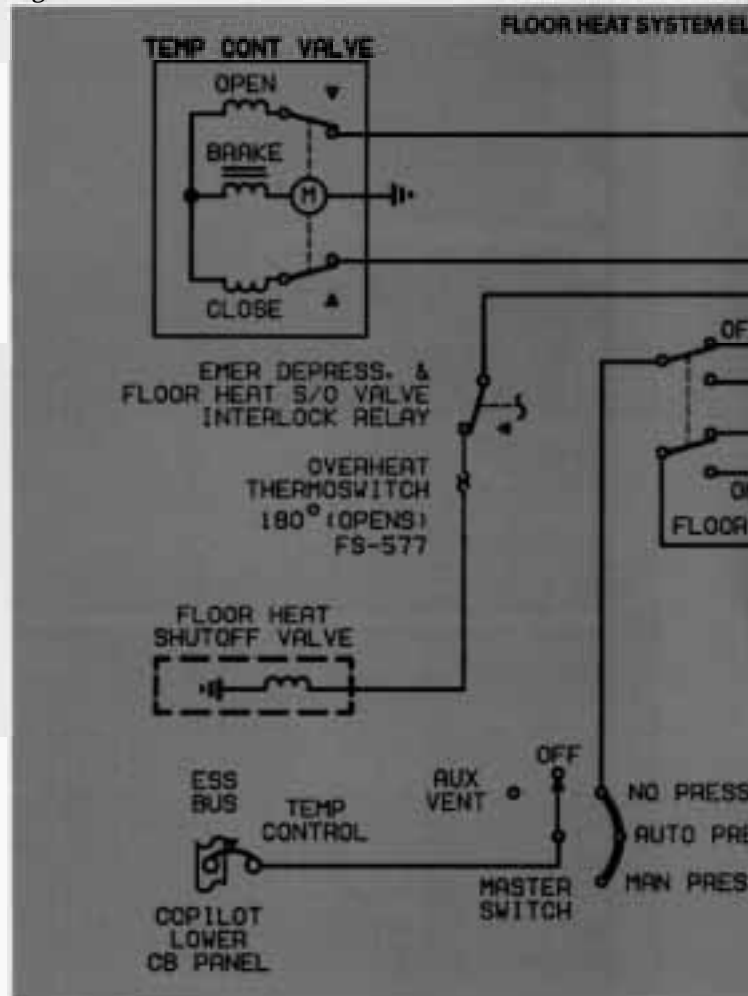
Two valves control floor heating, a solenoid-controlled, air-operated shutoff valve and a motor-driven temperature control valve. The valves are located in the upper right wheel well area next to the cargo compartment flow control and shutoff valve.

Underfloor heating is accomplished by mixing bleed air with ambient underfloor air and piping the mixture through forward and aft distribution ducts. The amount of bleed air supplied is regulated by the floor heat temperature control valve.

Figure 3 shows the electrical control circuit for the floor heat system. When the air conditioning master switch is

When the system is turned on, power is supplied to energize a relay which then supplies 3-phase power to operate the cargo compartment air recirculation fan. Fan power is supplied from the LH AC bus. This requires the use of ground power or at least two engine generators. When the system is turned off, the fan can be operated by a separate FAN switch located next to the floor heat switch on the air conditioning control panel.

If a malfunction of the control system occurs such that this air temperature reaches 180 degrees F, the thermostat actuates to remove power from the shutoff valve, causing it to close. Since the thermostat will automatically reset when the temperature drops about 20-30 degrees, the system will cycle on and off unless turned off by the floor heat switch.

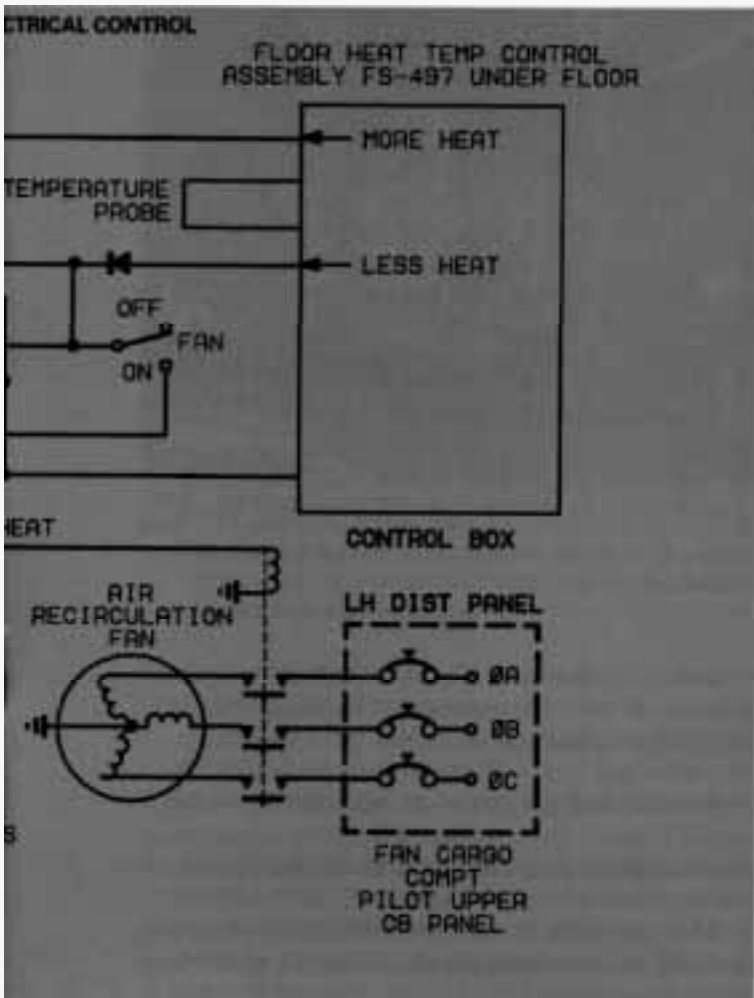
Floor heat thermostat and control box.

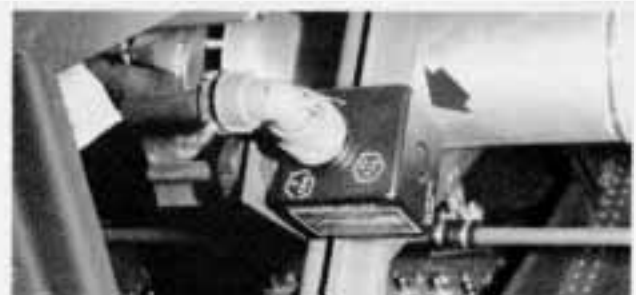
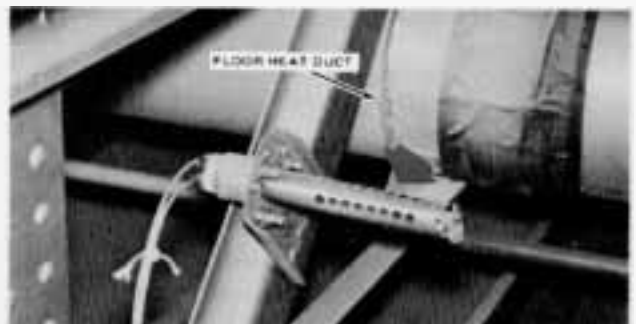
Bimetallic thermostat
