VOL. 16, NO. 3, JULY-SEPTEMBER 1989

SERVICE NEWS

TEFLON HOSES—AN APPLICATIONS GUIDE

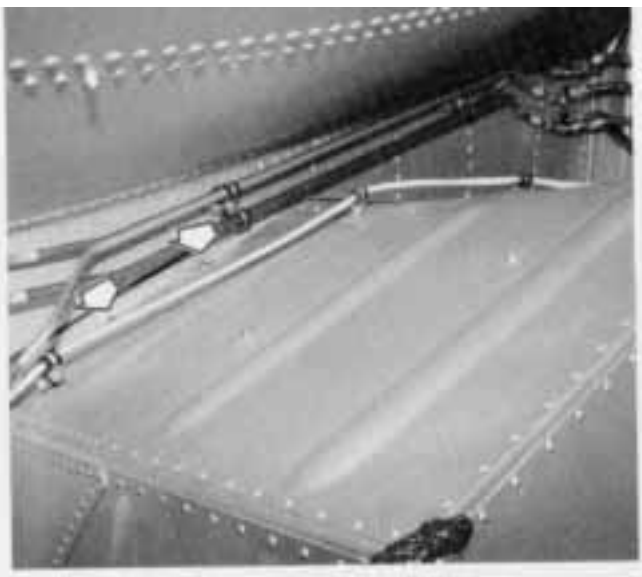
The problem in question had been observed during ascent to cruising altitude and was repetitive in nature. After extensive troubleshooting, it was found that the upper panel of the battery box (at the FS 165 pressure bulkhead) was separating from the aft upper attach angle between the fasteners whenever the aircraft was pressurized. Deflections of the battery box panel were causing oil-canning and the resulting popping sounds.

Two of the five rigid fasteners that can be replaced with NAS 1298 shoulders screws and spring washers are visible in this photograph.

Engineering analysis has determined that the problem does not present a safety of flight concern, but a change has been proposed that will eliminate the possibility of unwanted noises from this source in future production aircraft. The change replaces the rigid fasteners at the battery box attaching flange with spring washers and NAS 1298 shoulder screws. The new arrangement will allow a small amount of movement between the components during pressurization without the accompanying sound effects.

This same modification could also be accomplished on in-service aircraft subject to battery box noises. If any of your organization's Hercules aircraft have recorded this complaint and you wish to correct the problem, please contact the C-130/Hercules Service Department at the address below and request full information, including print No. 339275, Box Installation-Battery and External Recep. (note in particular reference
