SERVICE NEWS

VOL. 10, NO. 3, JULY—SEPTEMBER 1983

**RUDDER
THRUST
BEARING
SERVICING**

Controlling Rudder Thrust Bearing Wear

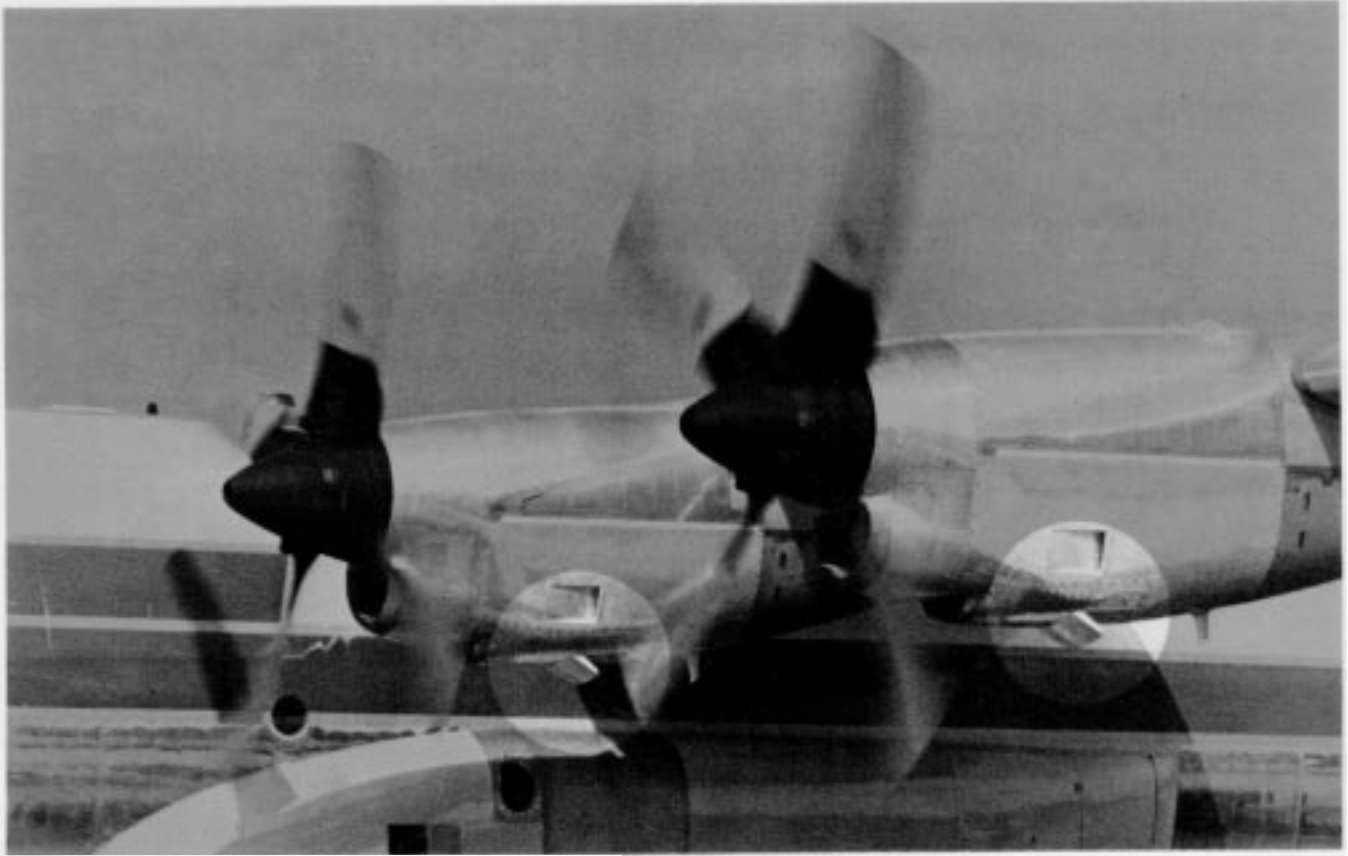
Figure 2. Oil cooler flaps-shown full open prior to takeoff.

One such occurrence involved a Hercules aircraft equipped with three glass-mercury thermostats and one solid-state thermostat. On the ground, with all oil cooler flap switches in automatic, the cooler flaps were full open (Figure 2). As power was applied for takeoff, the oil cooler flaps that were controlled by the glass-mercury thermostats moved toward the closed position and the oil temperatures stabilized at 85°C. The cooler flap controlled by the solid-state thermostat remained open until the oil cooler flap switch was placed to CLOSE. When the flap reached 40%, the switch was placed back to AUTOMATIC, at which time the flap continued to close to about 5% open. With this oil cooler flap at 5%, the oil temperature stabilized at 76°C.

controlled oil cooler flap did not automatically close in this case can be traced to the interaction of the oil temperature control thermostat and the thermostatic bypass and relief valve assembly in the oil cooler regulator valve.

The oil cooler regulator valve directs oil into or bypasses oil around the oil cooler, depending on the temperature of the oil (Figure 3). When the temperature of the oil is less than 54°C (+/-3°), the thermostatic bypass and relief valve is fully open. This allows most of the oil flowing into the oil cooler regulator valve to bypass the oil cooler. At approximately 54°C, the bypass valve starts to close and should be fully closed when the oil temperature reaches approximately 68°C. With the bypass valve fully closed, all the oil entering the regulator valve goes through the oil cooler.
