SERVICE NEWS

Vol. 1, No. 3, July- September 1974

Troubleshooting the Hercules Fuel Quantity

INDICATING SYSTEM

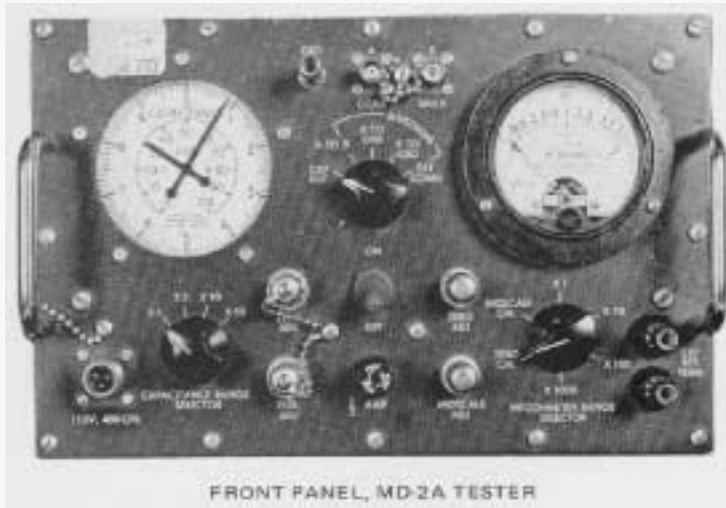
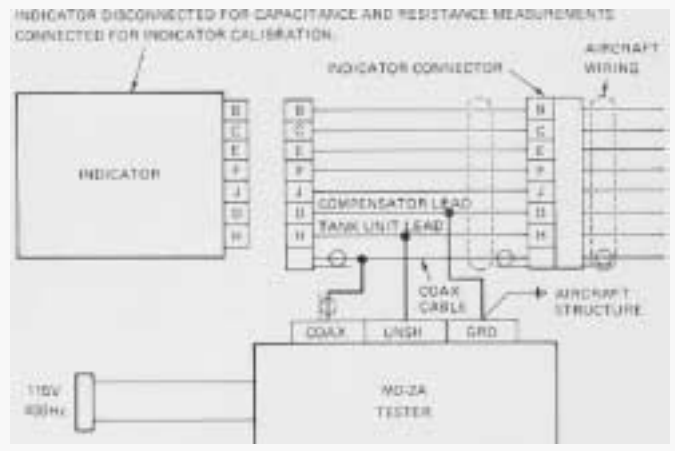
FIGURE 1

CONNECTION OF MD-2A

Open the circuit breaker for the system being tested, disconnect the cockpit indicator, and connect the calibration harness and MD-2A or TF-20 per Figure 1 or Figure 2.

CAUTION: Connect *ground wire from MD-2A or TF-20 per Figure 1 or Figure 2 before connecting to power source.*

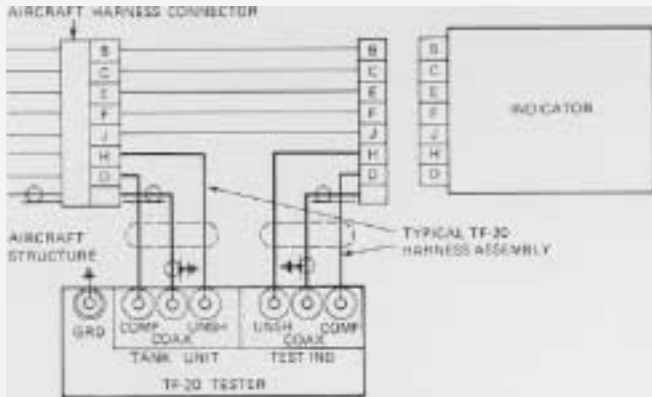
FIGURE 2

CONNECTION OF TF-20

Connect TF-20 per Figure 2, except leave the aircraft harness connector disconnected, and proceed as follows:

Position TF-20 power switch to OFF and connect to indicator and aircraft harness per Figure 2.

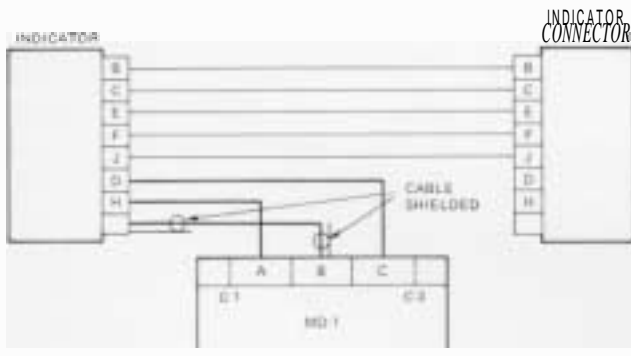
FIGURE 3

Indicator improperly calibrated.

**CONNECTION OF MD-1
(ALTERNATE CALIBRATION)**

If the tank contains fuel, disconnect the indicator and connect calibration harness and MD-1 (FSN/6625-302-4802) as shown in Figure 3. The MD-1 Tester supplies equivalent capacitance for testing and calibrating fuel quantity indicators. Adjust the C-3 section of the MD-1 to 62.0 MMF and the C-1 section to the nominal empty value of capacitance for the tank being checked. (See Table 2).

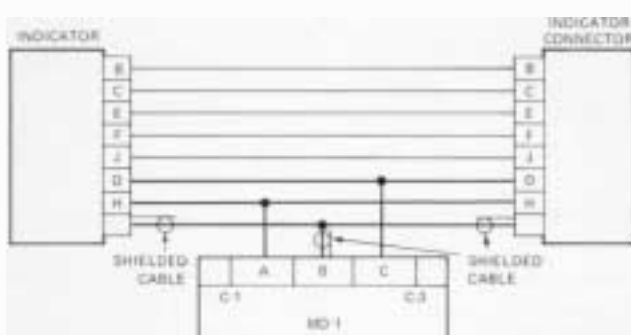
FIGURE 4

**CONNECTION OF MD-1
(PREFERRED CALIBRATION)**

If the check demonstrates that the indicator is improperly calibrated, it is preferable to drain the tank and calibrate the indicator to a dry tank (preferred method Figure 4). If time will not permit the preferred method of calibration, the indicator can be calibrated for "empty", using the nominal empty capacitance, and for "full", using the nominal full capacitance ("empty" plus added capacitance). When using this alternate method, you are assuming the integrity of the tank wiring and probes. Some degree of confidence in this method of calibration can be had by using a dipstick if the aircraft is in a level attitude (0 roll and 0 pitch).

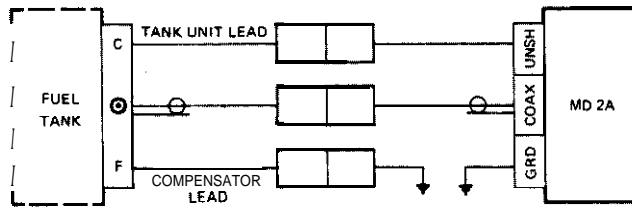
FIGURE 5

Open circuit in shield between individual probes within the tank.

CONNECTION OF MD-2A AT TANK BOUNDARY (CAPACITANCE CHECK)

With the MD-2A connected per Figure 5, disconnect the connector(s) at the tank boundary. With MD-2A Megohmmeter Range Selector at XI, position the Capacitance-Megohms Selector to A TO GRD. Megohmmeter should read infinite resistance (full CCW). Connect a jumper from the coaxial cable center conductor to the shield at the tank boundary connector and observe megohmmeter for continuity (no change: open shield-full CW: continuity).

If open, isolate to a connector and repair as necessary.

If continuity exists with the MD-2A connected and operated as described above, the open circuit is in the tank. With the tank drained and purged and the MD-2A connected per Figure 5, use the megohmmeter section of the MD-2A to isolate open shield. (Text continued on Page 12)

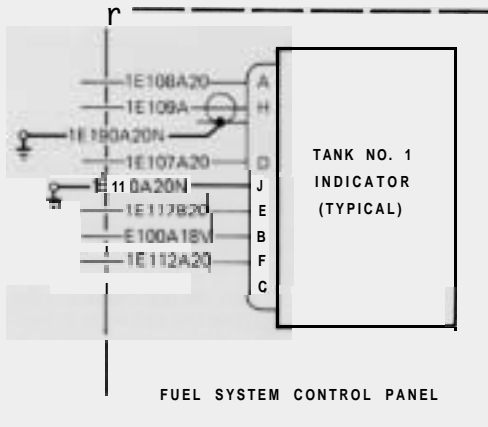
FIGURE 7

GROUND STUDS

Clean and/or tighten ground stud. (See Figure 7)
