SERVICE NEWS

MAIN LANDING GEAR RUB

Vol. 13, No. 1, January - March 1986

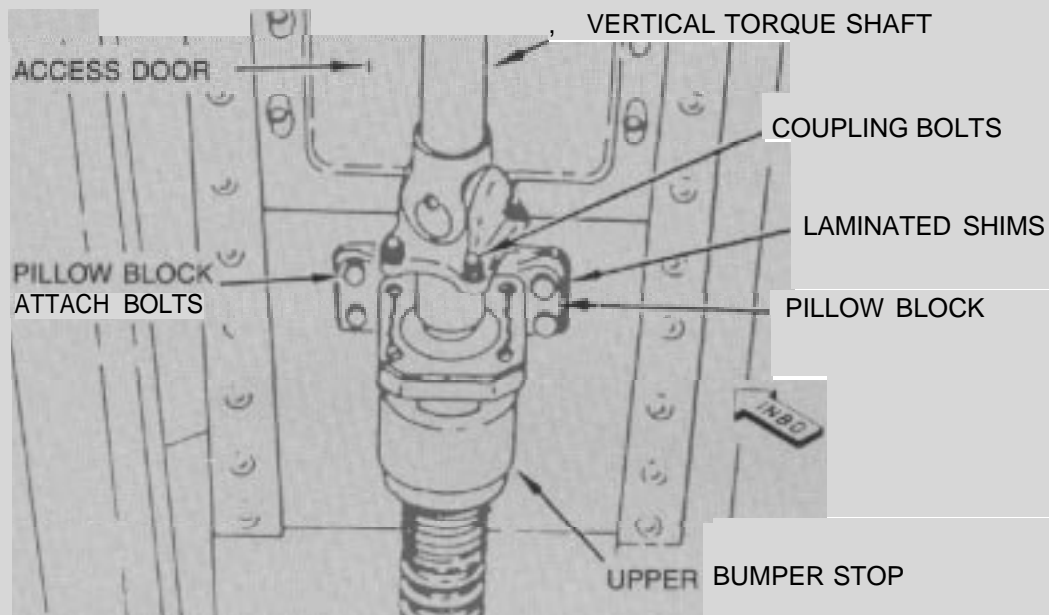
Figure 3. Pillow block installation.

If a main landing gear strut has a rubbing condition that cannot be corrected by the above measures, check to see whether the aircraft has the thick (0.130 inch) serrated plates (P/N 372602-11, and -1R) installed between the upper shoes and the swivel bracket (see Figure 3).

If the thick serrated plates are present on the aircraft in question, the rubbing condition can be relieved by substituting the thin (0.065 to 0.070 inch) serrated plates (P/N 372602-3 and -4). The use of the thinner serrated plates shifts the position of the main landing gear piston/axle slightly outboard, thereby increasing the clearance in the contact area.

Note that plates should be replaced in pairs, and that a combination of thick and thin plates on one swivel bracket is not acceptable. If the P/N 372602-3 and -4

thin serrated plates are not readily available, the -IL and -IR thick plates can be modified to the thinner -3 and -4 configuration by machining the inside of the channel section web to 0.065 to 0.070 inch in thickness. Then replating the reworked area with cadmium.
