VOL. 2, NO. 2, APRIL-JUNE 1975

SERVICE NEWS

A SERVICE PUBLICATION OF LOCKHEED-GEORGIA COMPANY, A DIVISION OF LOCKHEED AIRCRAFT CORPORATION

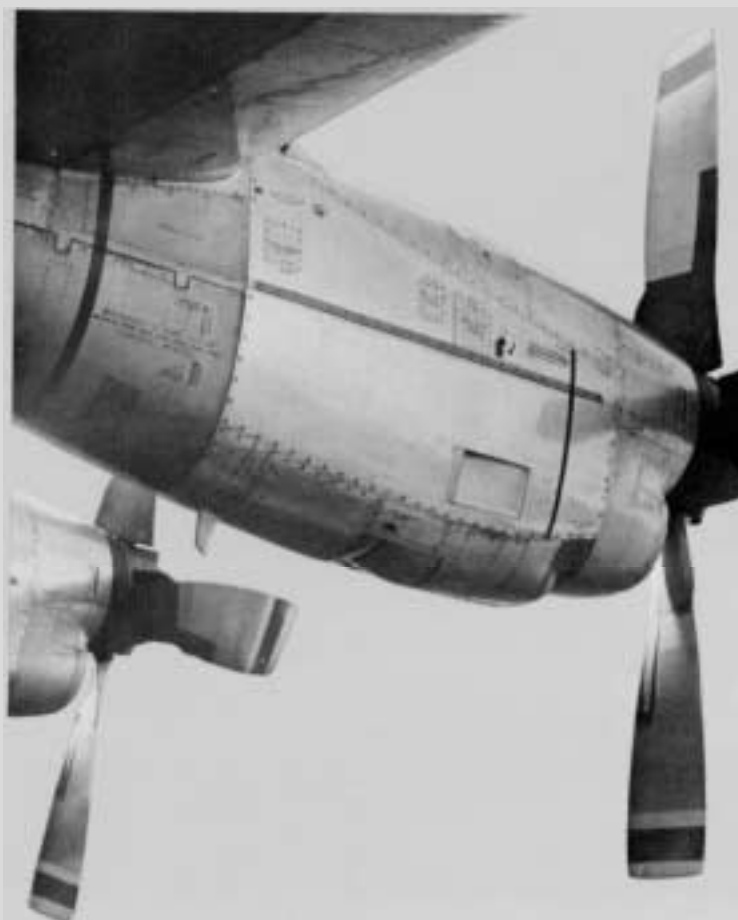
THE EXTERNAL SCAVENGE OIL FILTER

The pressure pumps incorporate 104 micron filters. The external scavenge oil filter adds 20 micron filtration to the system. This means very small particles will be filtered from the oil. The filter element is likely to clog quickly when installed in a “dirty” oil system. Integral with the filter assembly is a differential pressure indicator to alert maintenance personnel when an element change is necessary.

One problem experienced with the external scavenge oil filter is popping of the filter button shortly after installation of the kit. As mentioned above, if the filter is installed in a “dirty” oil system the element will need to be replaced early. The element should be replaced as soon as the need is indicated.

If the filter is installed on an engine where the QEC scavenge oil system back pressure exceeds the allowed 30 PSI before installing the filter, then the addition of the filter could result in problems as the element begins to clog. To minimize this problem, the QEC scavenge back pressure should be checked following installation of the external scavenge filter kit. Refer to T.O. 2J-T56-26 or -46 or applicable commercial documents for instructions. The usual corrective action to reduce the back pressure is to clean/replace such components as the fuel heater and oil cooler.

Another factor which can contribute to high back pressure and associated problems is incorrect installation of the filter element. It should be installed with the element tangs “UP.” Some elements are stamped on the tang end with the word “TOP.” Mis-installation results in a higher than normal filter differential pressure and button “popping” The oil system hoses should be checked to see if they were kinked during installation. Any of these problems can cause oil venting from the overboard drain during flight. Replacement of the filter element and/or checking and correcting the QEC back pressure should correct the problem. If venting continues, consideration should be given to possible inefficiency of the main scavenge oil pump.

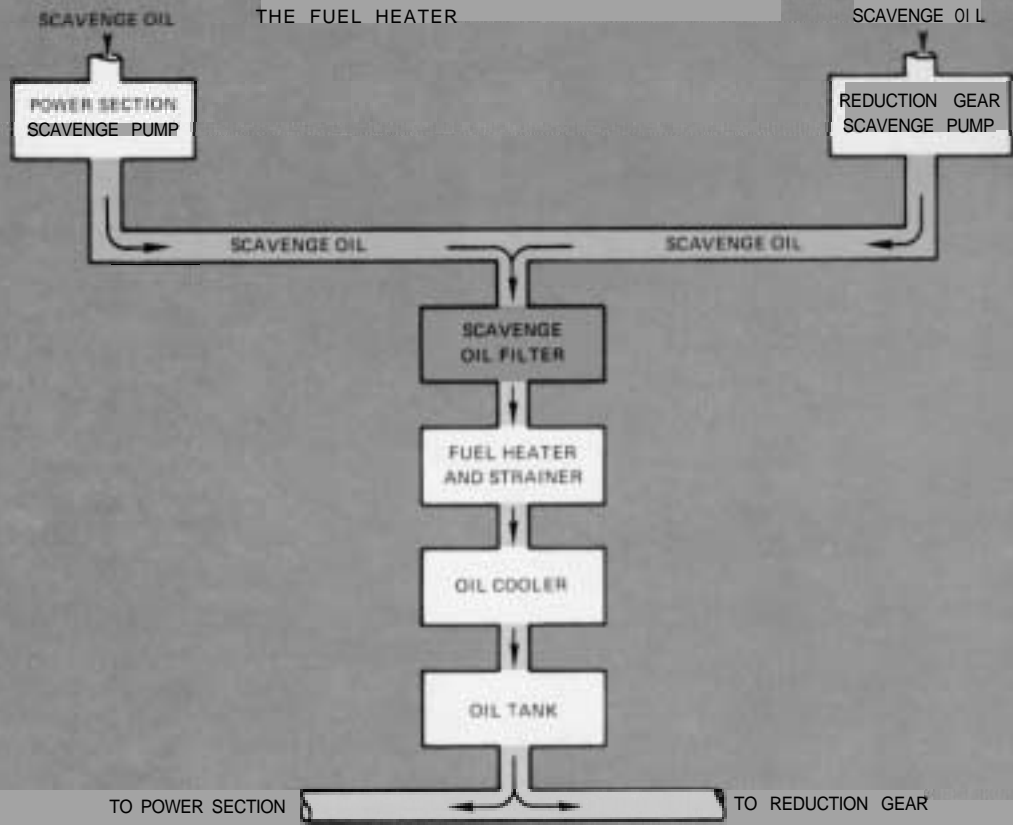
FIGURE 1

THE EXTERNAL SCAVENGE OIL FILTER ILLUSTRATED IN FIGURES 1 AND 2, IS LOCATED BETWEEN THE SCAVENGE PUMP OUTLETS AND THE FUEL HEATER

The external scavenge oil filter kit improves the service life of the engine by removing carbon particles and other foreign material from the engine oil which could damage the contact surfaces of highly loaded bearings, gears, and seals. Sludge formation is reduced throughout the engine, oil cooler, and tanks. Restriction of the engine oil jets is significantly reduced. The possibility of cross-contamination in the event of power section or gear box failure is minimized. Further, debris from such failures is kept out of the QEC (Quick Engine Change) oil system components.

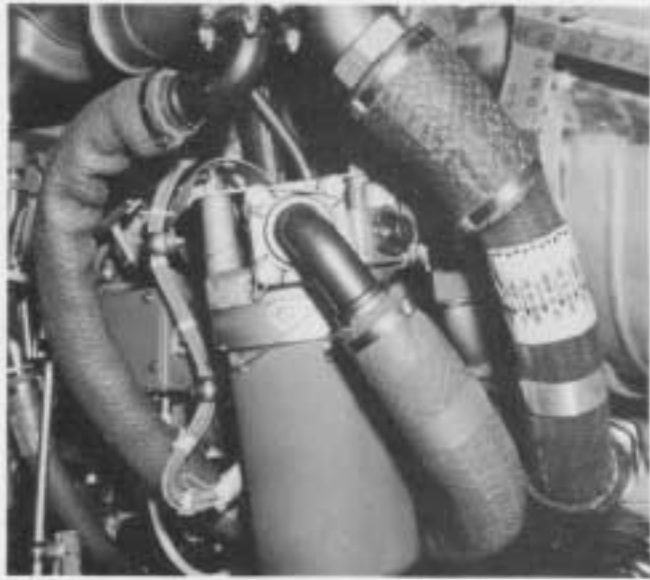
FIGURE 3. (above) A differential pressure (clogged filter) indicator is integral to the filter assembly. FIGURE 4. (right) It is difficult to install the element upside down – remember the tang end goes up. Sometimes stamped with the word “top”.

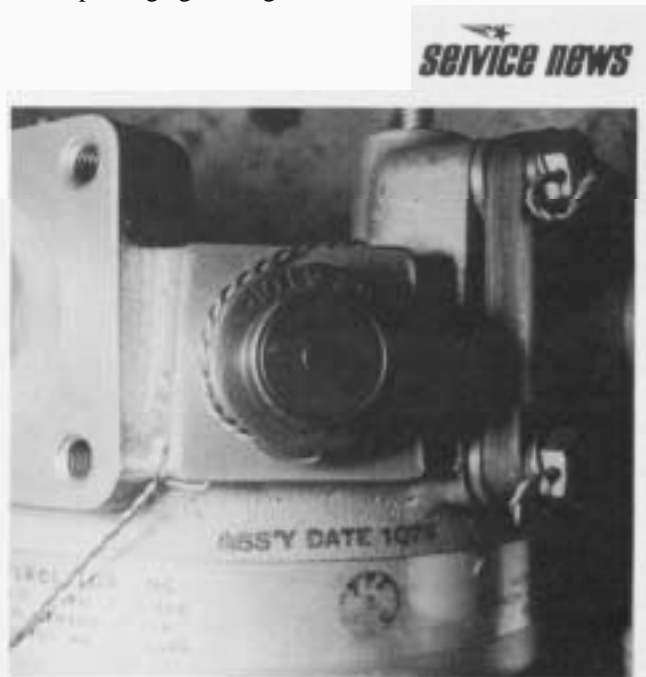
FIGURE 5. When resetting the indicator button make sure it is well seated – but don't use excessive force.

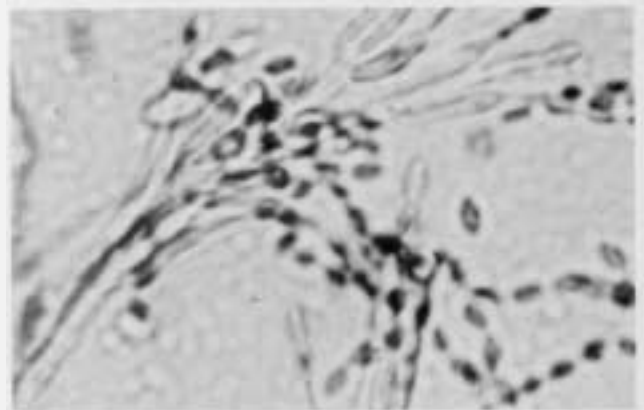
FIGURE 1. Microbial growth - this is a magnification of microbial growth in the water layer of a fuel tank.

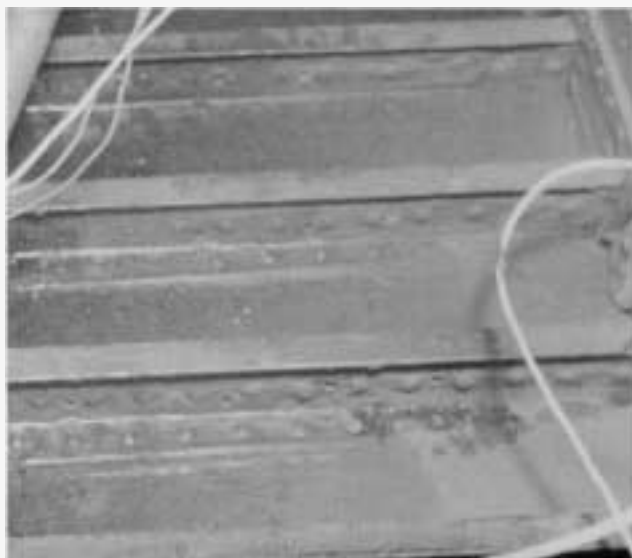
FIGURE 2. A C-130 fuel tank showing the bug growth (black mat) attached to the tank bottom. Tank coated with Buna-N (MI L-C-4383) which is nutrient to the bugs.

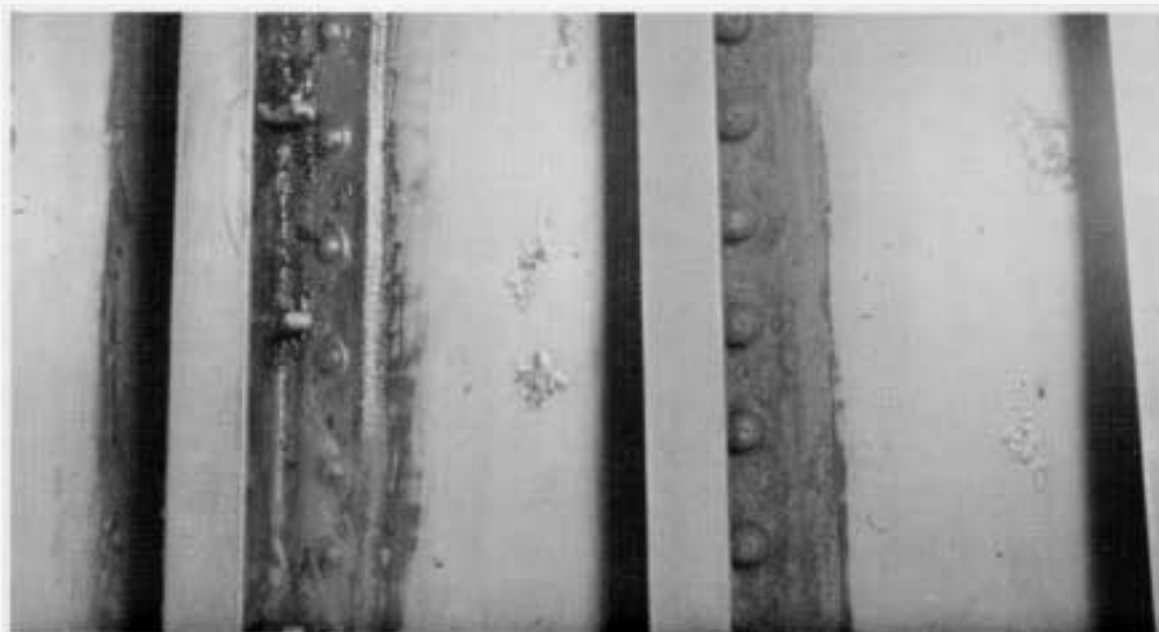
FIGURE 3. C-130 fuel tank after removal of the Buna-N shows the corrosion blisters and pockets.

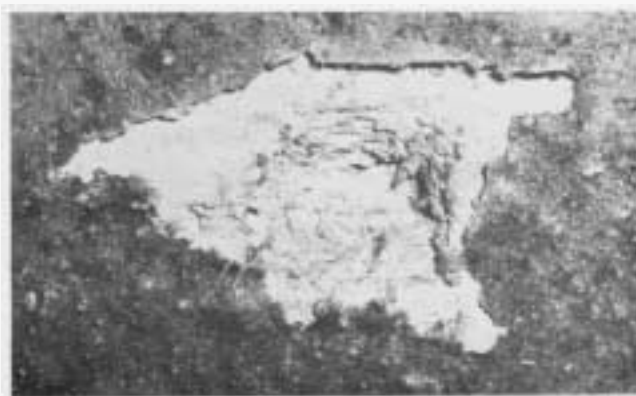
FIGURE 4. (above) A close-up of exfoliation corrosion this corrosion can penetrate the entire thickness of the skin plank.
 FIGURE 5. (right) The PFA 55MB can keep your fuel free of microorganisms when properly used.

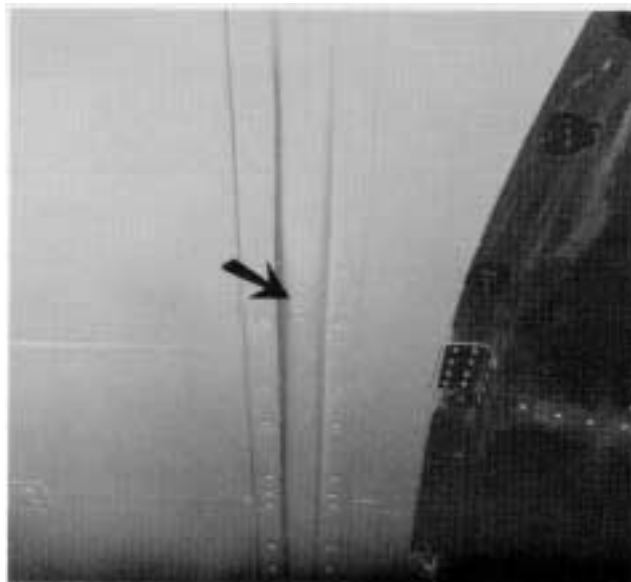
Current production Hercules and those with new center wings have a single manual condensate drain valve at Wing Station 174 near outboard wall of aux tank cavity.

The outboard drain valves on early Hercules (through 4299), that have not been modified, consist of 14 manual drain valves located at approximately wing station 174. On Hercules of recent production and those having center wings modified to the new configuration, the outboard drains (located at the same wing station 174) consist of 14 holes which are permanently open. These holes allow drainage into a trough that is fitted with a single manual drain valve. (See Photograph on Page 15). If any fuel, colored or clear, is observed at the inboard drains or can be drained from any of the manual drain valves, a leak from an auxiliary tank or plumbing is indicated.

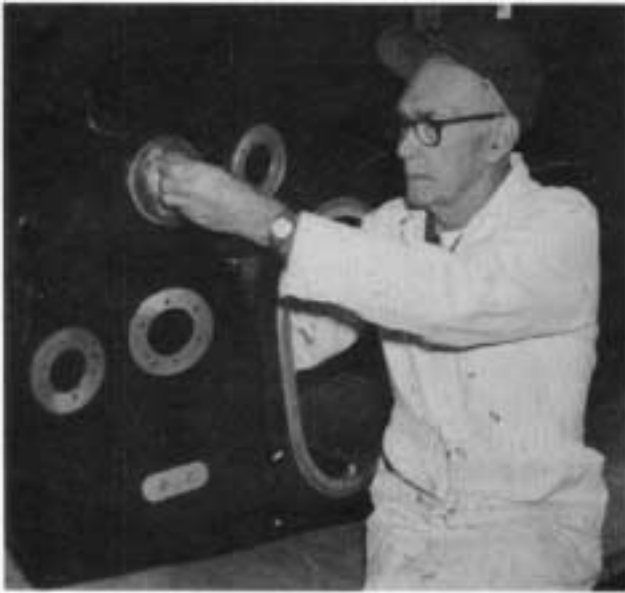
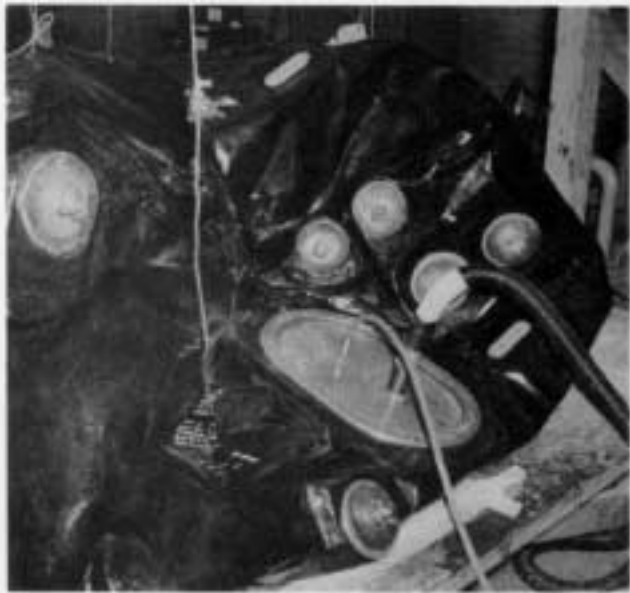
Rubber gaskets on plates cover openings, including bolt holes, to make bladder cells air tight. Cords suspended above work platform position bladder cell for inflation. A manhole cover provides connections for a manometer and air pressure. The cell below is inflated at 1/2 psi.

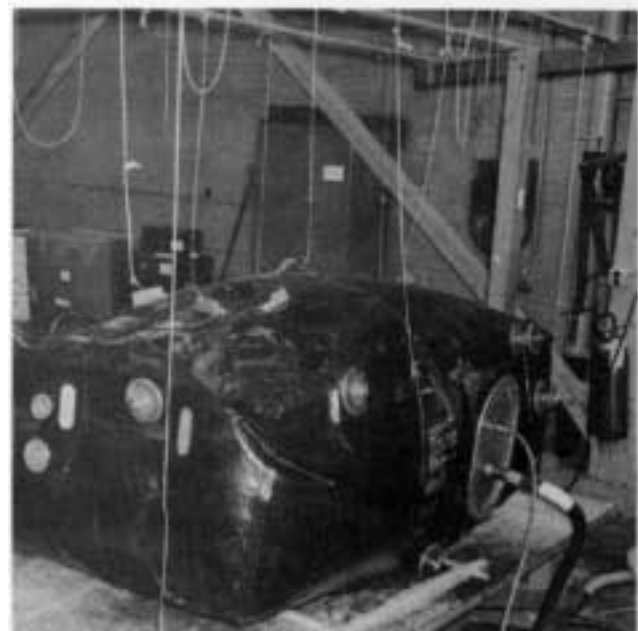
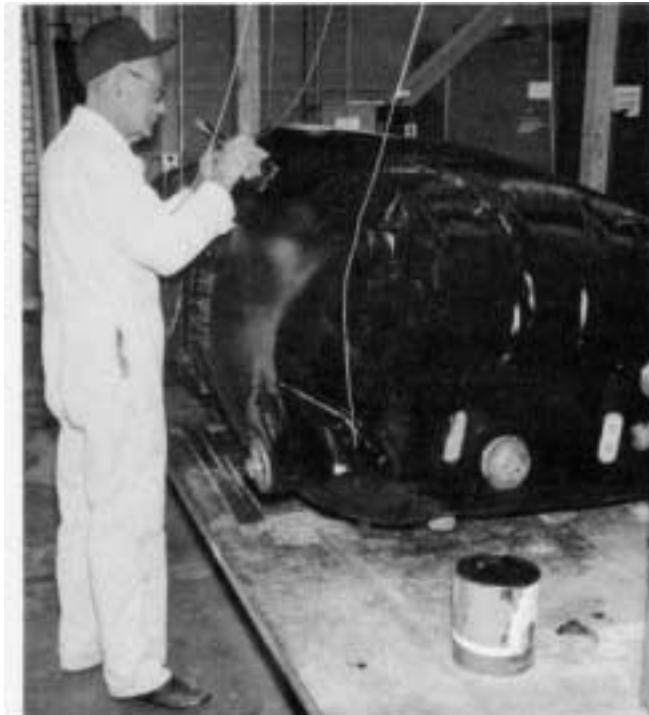
A center cell, bottom up, is receiving a brush coat of blue leak detection compound. White stenciled specifications show through the coating.

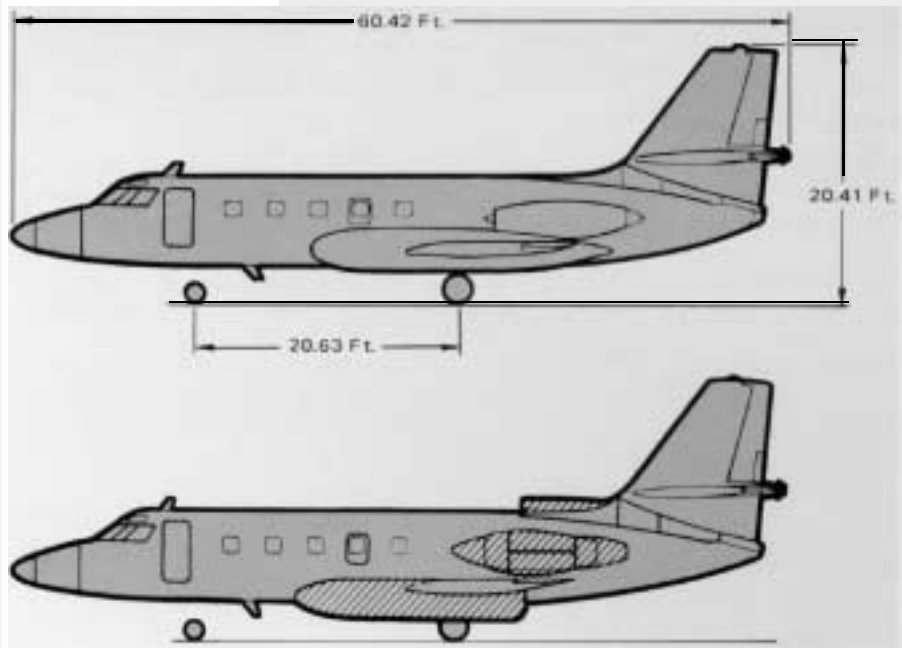
General Arrangement

Dash 8

Maximum Weight = 42,500 Lbs.
10 Passengers, 2 Crew

JetStar II

Maximum Weight = 44,000 Lbs
10 Passengers, 2 Crew

These drawings illustrate the external differences between the JetStar II and Dash 8. Overall dimensions, length, height, and wingspan, remain the same. The three most prominent differences are: larger nacelles, redesigned auxiliary fuel tanks and addition of a dorsal fin scoop.
