SERVICE NEWS

A SERVICE PUBLICATION OF LOCKHEED-GEORGIA COMPANY, A DIVISION OF LOCKHEED AIRCRAFT CORPORATION

Vol. 4, No. 3, July - September 1977

TIRES

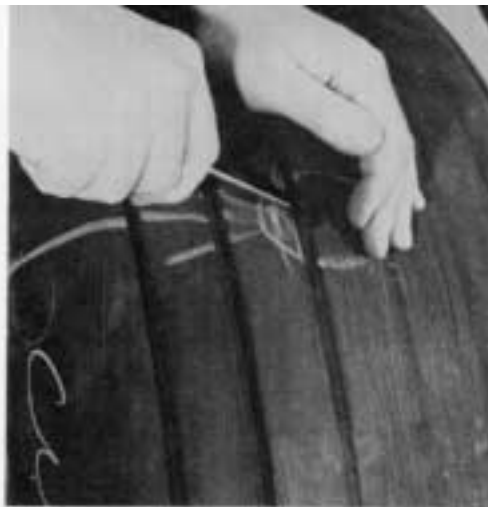
Probe foreign object damage with blunt awl:
shield work. Photo courtesy of S. F. Goodrich Co.

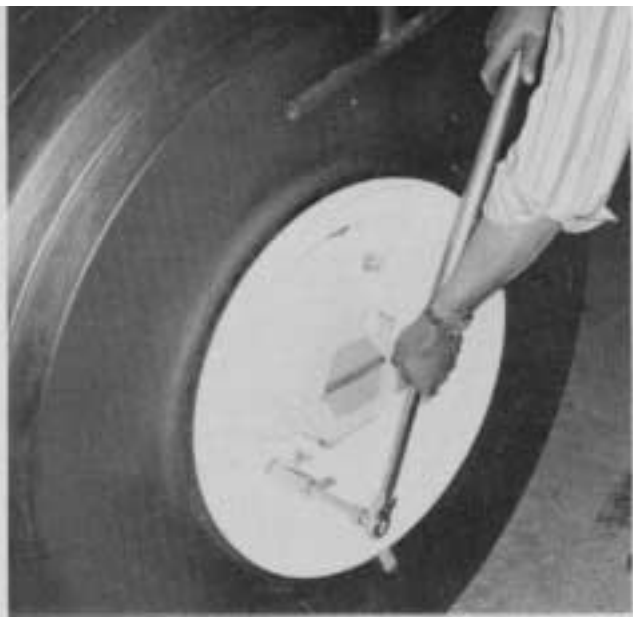
Tightening wheel bolts with torque wrench

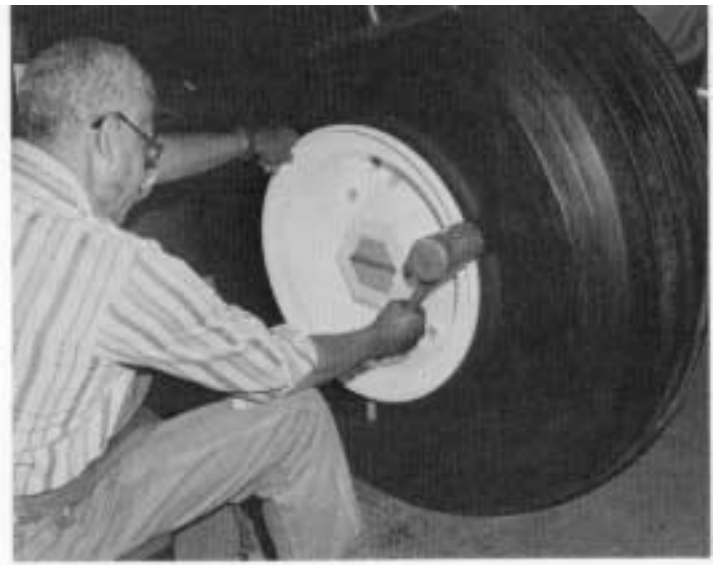
Putting wheel halves into tire.

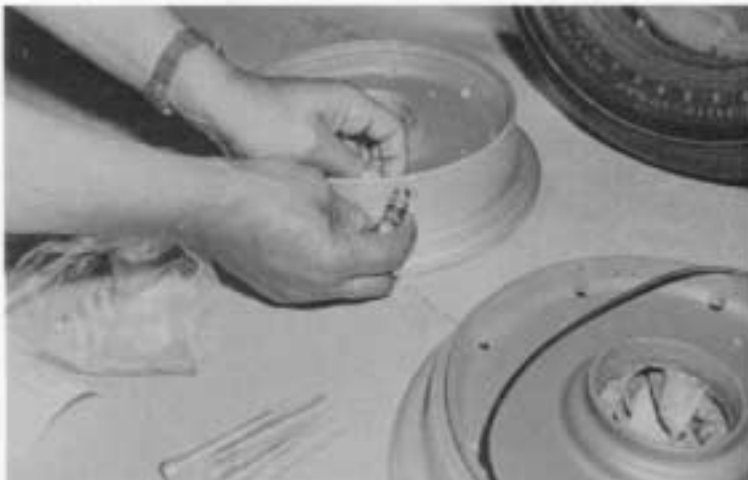
inserting valve stem into wheel.

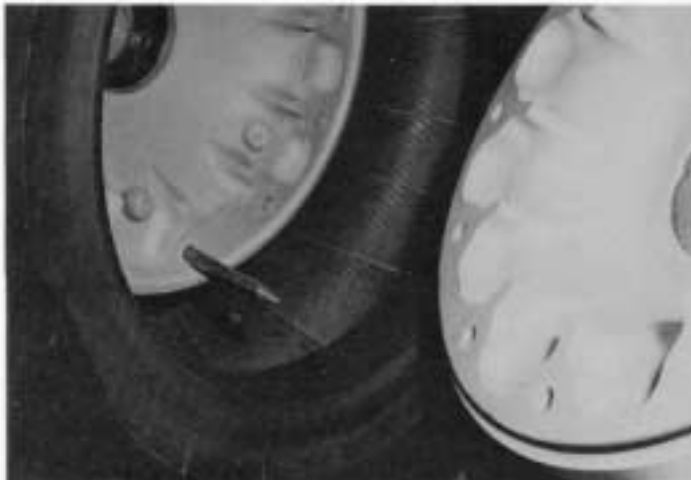
Guide pin used for alignment of wheel halves.

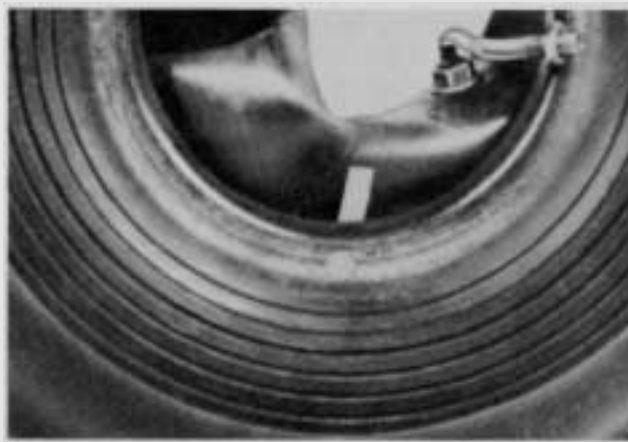
Tube balance mark (heavy point) aligned with tire balance mark (light point). Photo courtesy of B F Goodrich Co.

Balance marks appear on certain aircraft tubes to indicate the heavy portion of the tube. These marks are approximately 1/8-inch wide by 2 inches long. When the tube is inserted in the tire, the balance mark on the tube should be located at the balance mark on the tire. If the tube has no balance mark, place the valve at the balance mark on the tire.

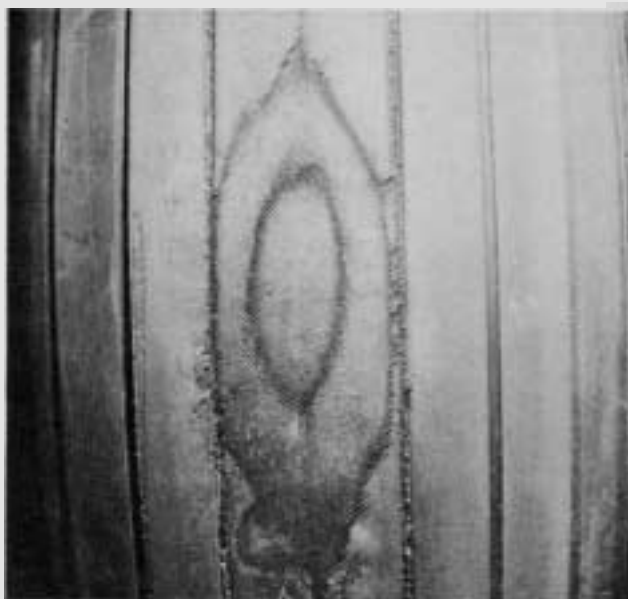
Worn through tread reinforcement strips only. O K for retread. Photo courtesy of B F Goodrich co.

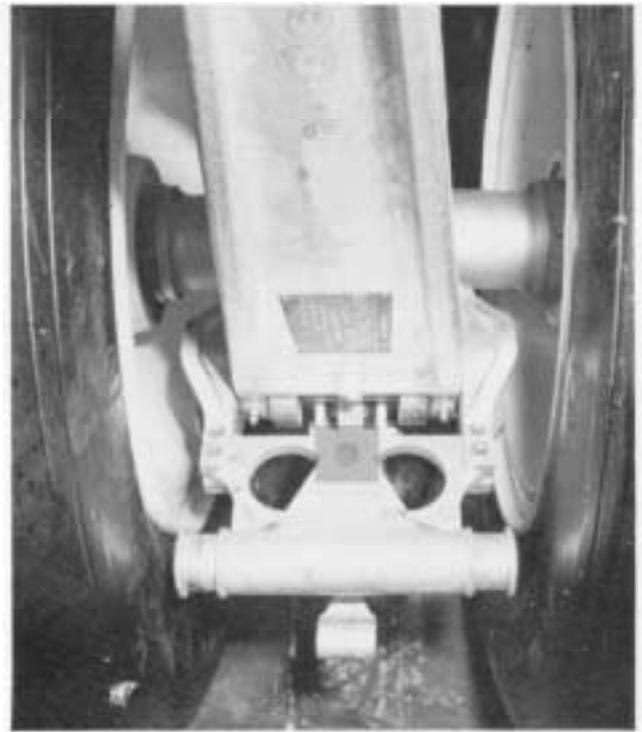
Figure 1 A SHEAR BOLT SECURES TOW FITTING TO CROSS BAR ON NOSE LANDING GEAR.

The newer towbar made by Ventura (P/N 126-000-101) has a towhead and towtube end connector made from general purpose structural steel. Although the steel used is of good quality, it does not provide for proper shearing of the AN6 bolts. Therefore, high strength steel bushings are used in the towtube-to-towhead attachment holes. These bushings must be sharp and flush at the towtube and towhead mating surfaces. Also, larger washers should be used to prevent the bolt head and nut from pulling into the bushing holes. (See Figure 2.)
