SERVICE NEWS

INTEGRAL FUEL TANKS

Vol. 9, No. 4, October-December 1982

3 Maintenance of Integral Fuel Tanks

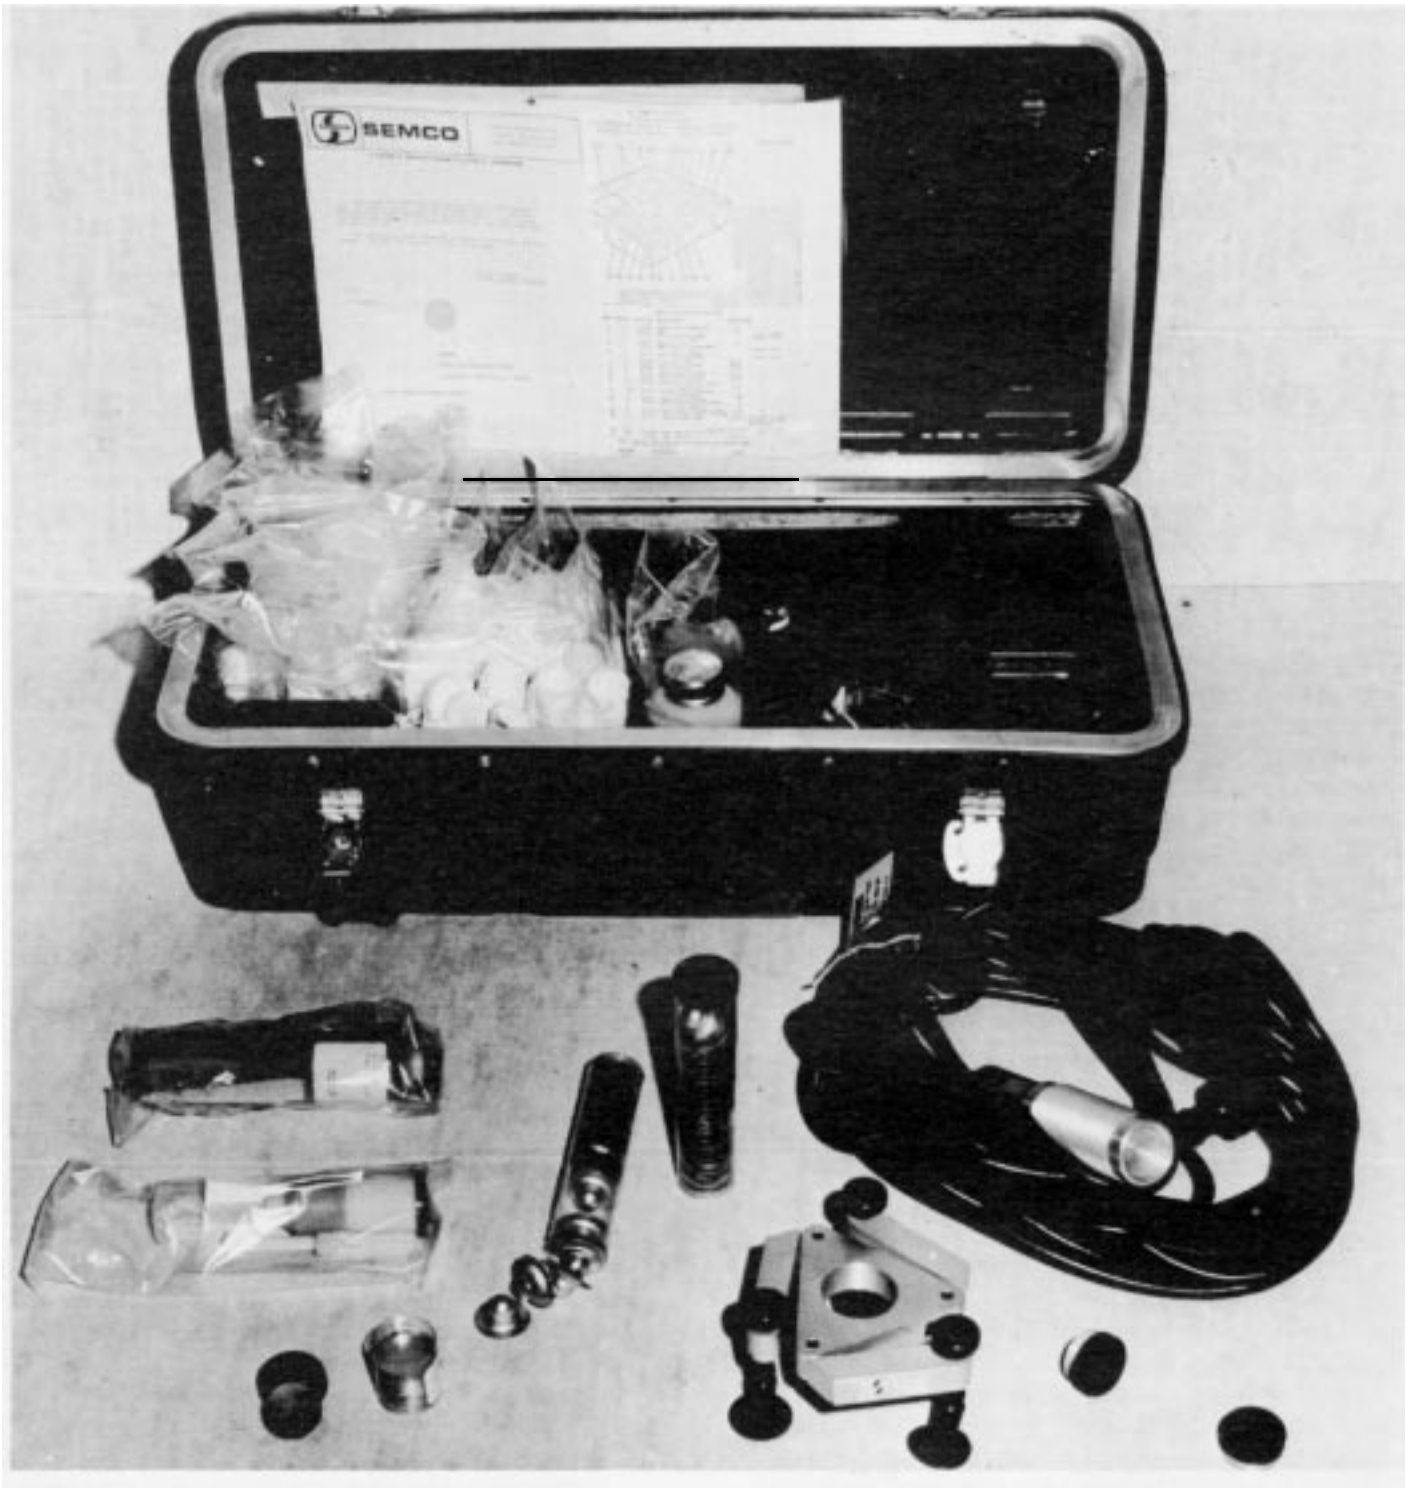
Figure 6. Semco Model 400A-1 Field Repair Kit.
